Factual Update

October 29, 2020

Incident Summary

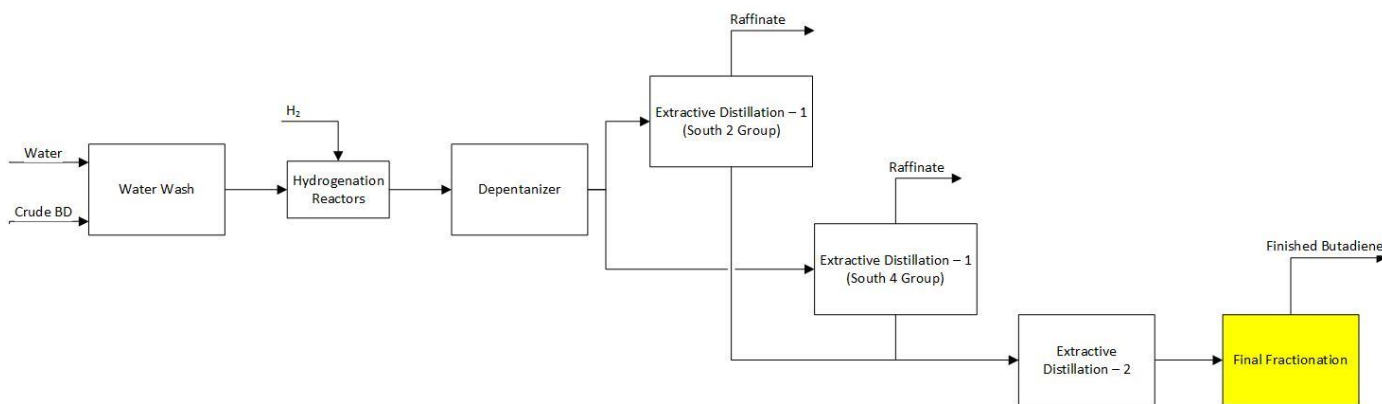
- **Figure 2** shows a block flow diagram of the butadiene production process at TPC PNO. Crude butadiene ranging from 35 to 75 percent purity proceeds through multiple production phases. After the final fractionation phase, the 1,3-butadiene is at 99.8 percent purity, where it is sent to storage tanks for shipping. The loss of containment occurred in the final fractionation phase.

Figure 2. Block flow diagram of the butadiene production process at TPC PNO. The highlighted area shows where the loss of containment occurred. (Credit: CSB)

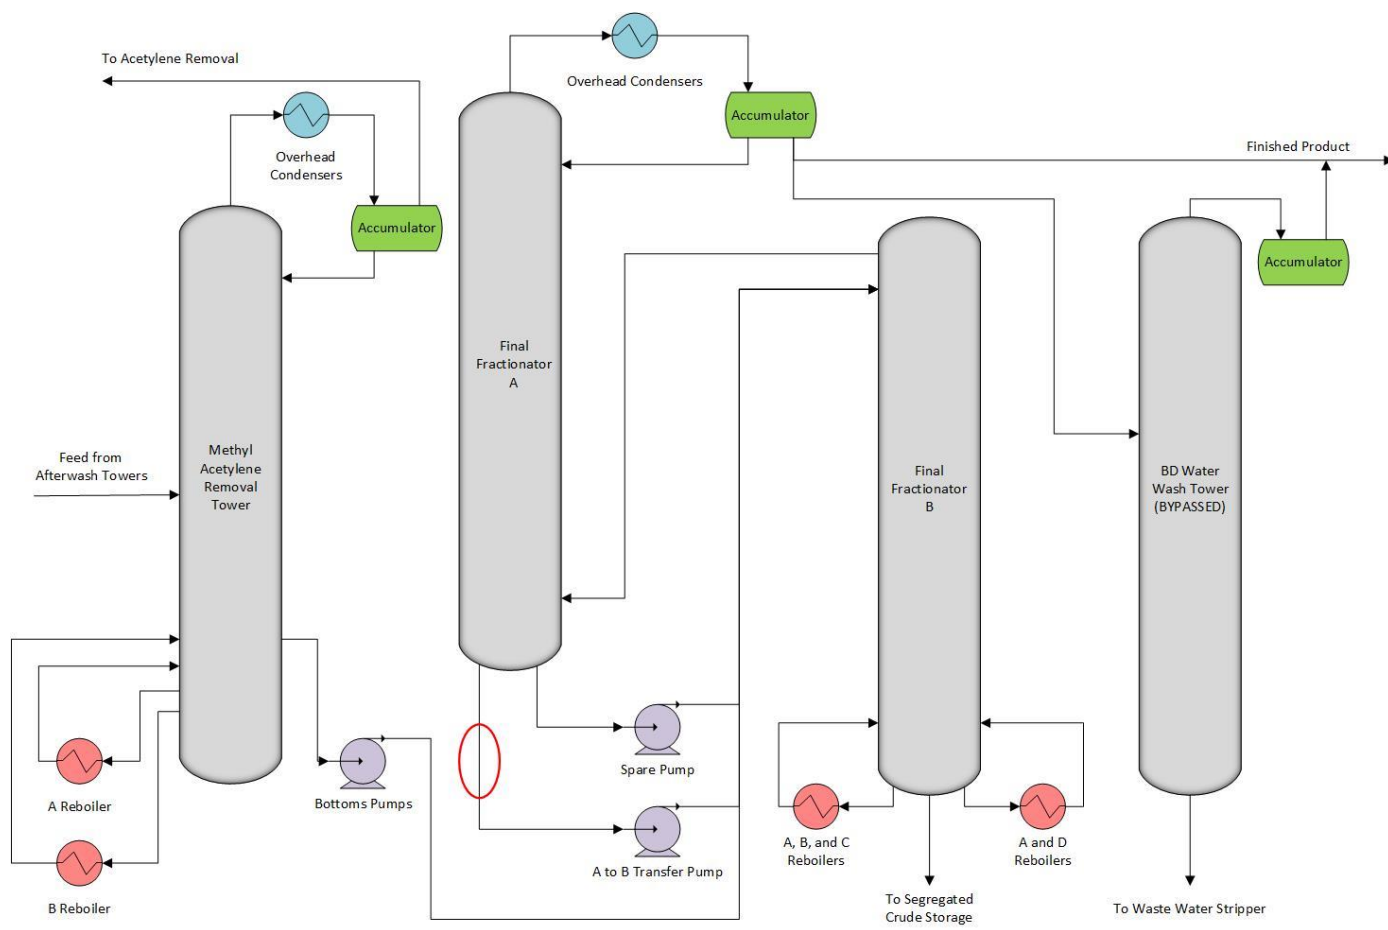
- A simplified process flow diagram of the TPC PNO butadiene post-fractionation process is shown in **Figure 3**. Indicated on the process flow diagram by the red ellipse is the area of interest as the potential origin of the flammable vapor release.^a

Figure 3. Simplified process flow diagram of the TPC PNO butadiene post-fractionation process at the time of the incident. (Credit: CSB)

^a The likely location of release is based on data from the final fractionator A level controller and eyewitness accounts. As of this update, the CSB has not been able to visually confirm the failure location due to the extensive damage at the site.

- The explosion heavily damaged piping and equipment in the unit. Some of the resulting ruptured portions of piping could not be isolated. For instance, the area of interest indicated in **Figure 3** lies between the final fractionator A and the final fractionator A to B transfer pump, and no remotely actuated isolation valve^a existed on that piping section upstream of the area of interest as the potential origin of release. Flammable process fluid continued to release from damaged equipment, and the fires burned for over a month. At 10:09 a.m. on January 4, 2020, the TPC Incident Command confirmed that all fires were out.

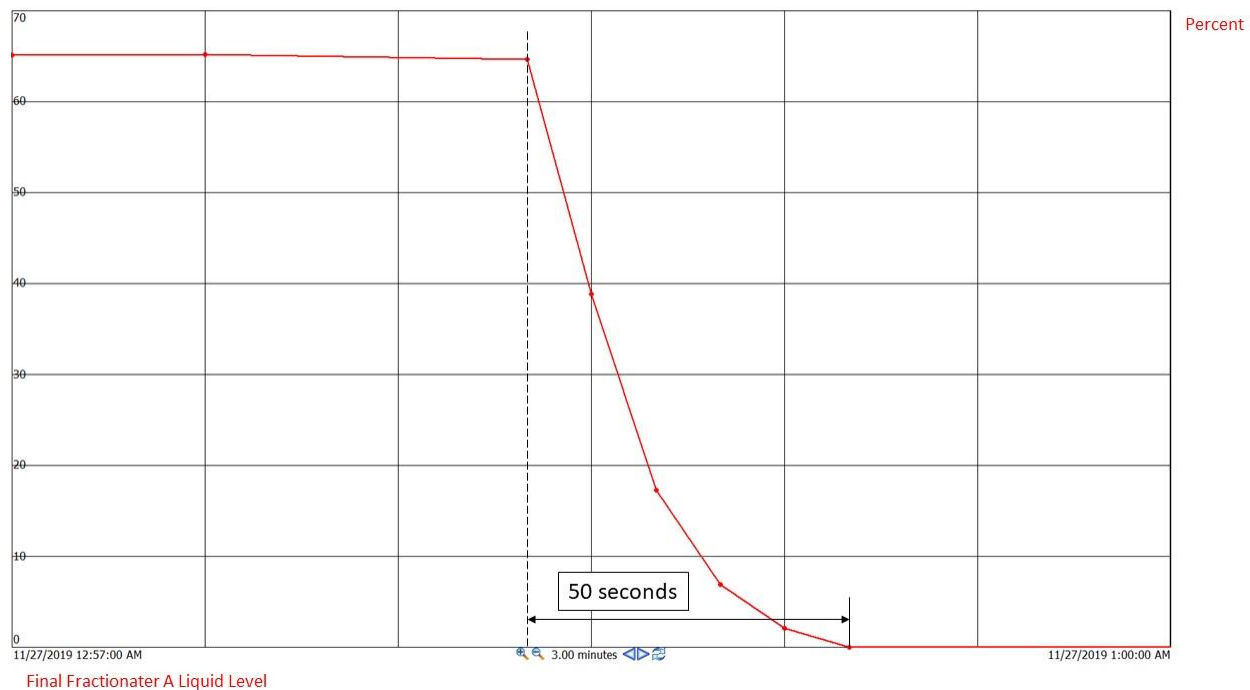
approximately 6,000 gallons. The liquid, which was primarily butadiene,^a emptied from the fractionator in less than a minute (**Figure 4**). The liquid vaporized upon release^b and formed a vapor cloud. Three workers were in the unit at that time. Two of them were facing toward the final fractionator A, and they both told the CSB after the incident that they saw a pipe rupture. Of these two workers, one of them identified the release point (circled in red in **Figure 3**) to be in the suction piping of the final fractionator A to B transfer pump. The third worker, who turned toward the sound of the release after the release occurred, also believed it was the suction piping into the final fractionator A to B transfer pump that failed. The workers' observations are consistent with the unit's recorded process data. The CSB has not yet visually confirmed the failure location due to the extensive damage and unstable structural conditions at the site.

Figure 4. Process data trend graph showing the liquid level (in percent) in the final fractionator A dropping from its operating level to zero in less than a minute. The estimated liquid quantity in the fractionator at the time of the release was 6,000 gallons (30,000 pounds).^d (Credit: CSB)

^d Volume calculated based on the final fractionator A dimensions and liquid level of six feet. The weight in pounds was calculated using an assumed density of 38.75 pounds per cubic feet liquid butadiene.

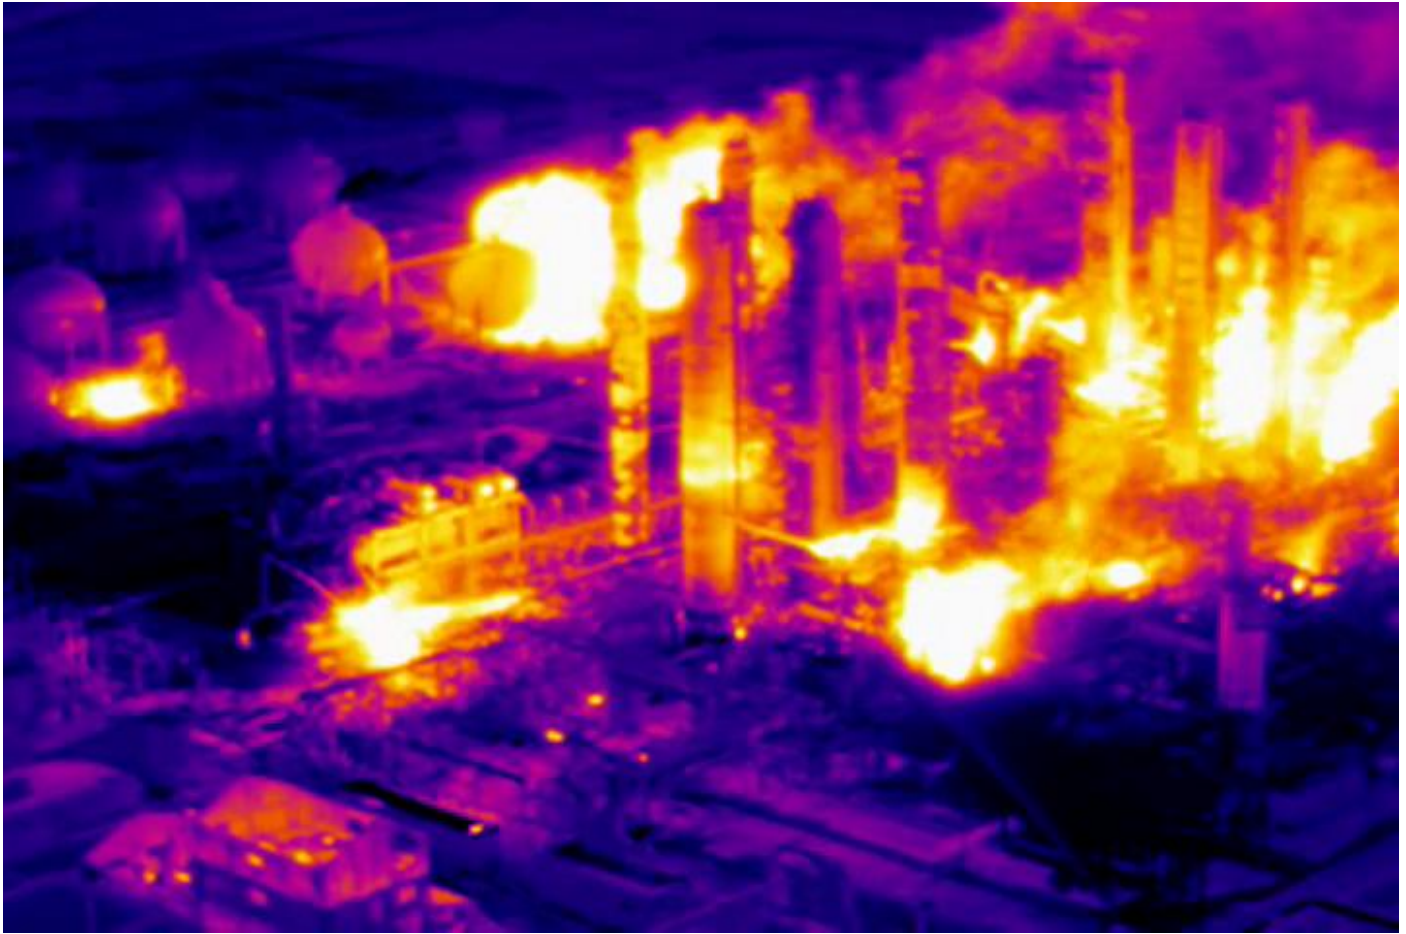
- Immediately following the loss of containment, the three workers quickly departed the unit.
- At 12:56 a.m., the vapor cloud ignited, resulting in an explosion that created a pressure wave that heavily damaged the site and caused damage to buildings, including houses, offsite. Thermal imagery^c provided by TPC shows multiple fires following the explosion (**Figure 5**).

Figure 5. Thermal drone imagery of the TPC PNO facility South Unit taken the morning after the initial explosion. (Credit: TPC)

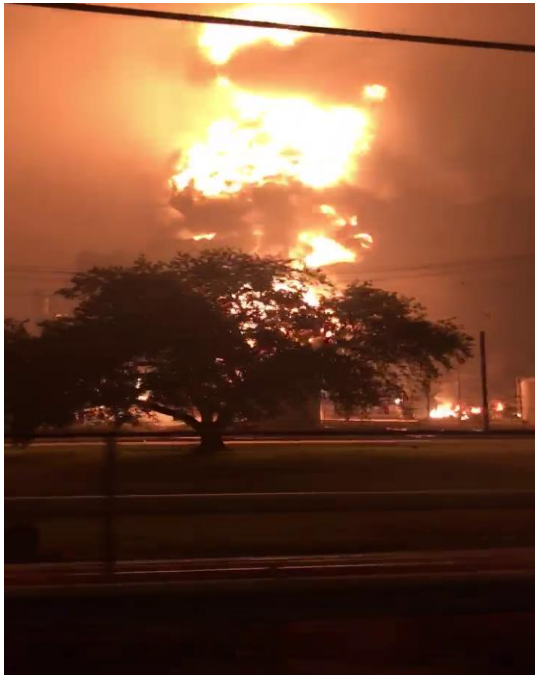
- At least two additional explosions occurred following the initial blast. At 2:40 a.m., a cell phone recording captured an additional explosion (**Figure 6**). That afternoon at 1:48 p.m., another explosion propelled one of the facility's towers into the air (**Figure 7**). The tower landed within the confines of the TPC PNO facility. In addition to the propelled tower (later identified as an out-of-service debutanizer), four additional towers (**Figure 8**) fell as a result of the blast and/or fires: the final fractionator A, an extractive distillation absorber, an out-of-service water wash tower, and the depentanizer.

Figure 6. Explosion at 2:40 a.m. on November 27, 2019 captured by cell phone video (Credit: TPC)

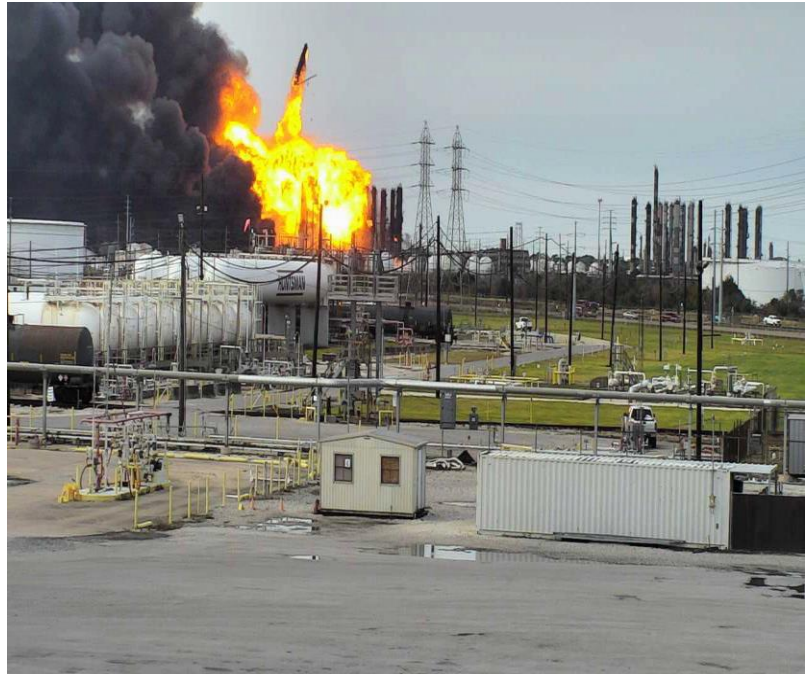
Figure 7. Explosion at 1:48 p.m. on November 27, 2019 which propelled one of the South Unit towers. (Credit: Huntsman Corporation)

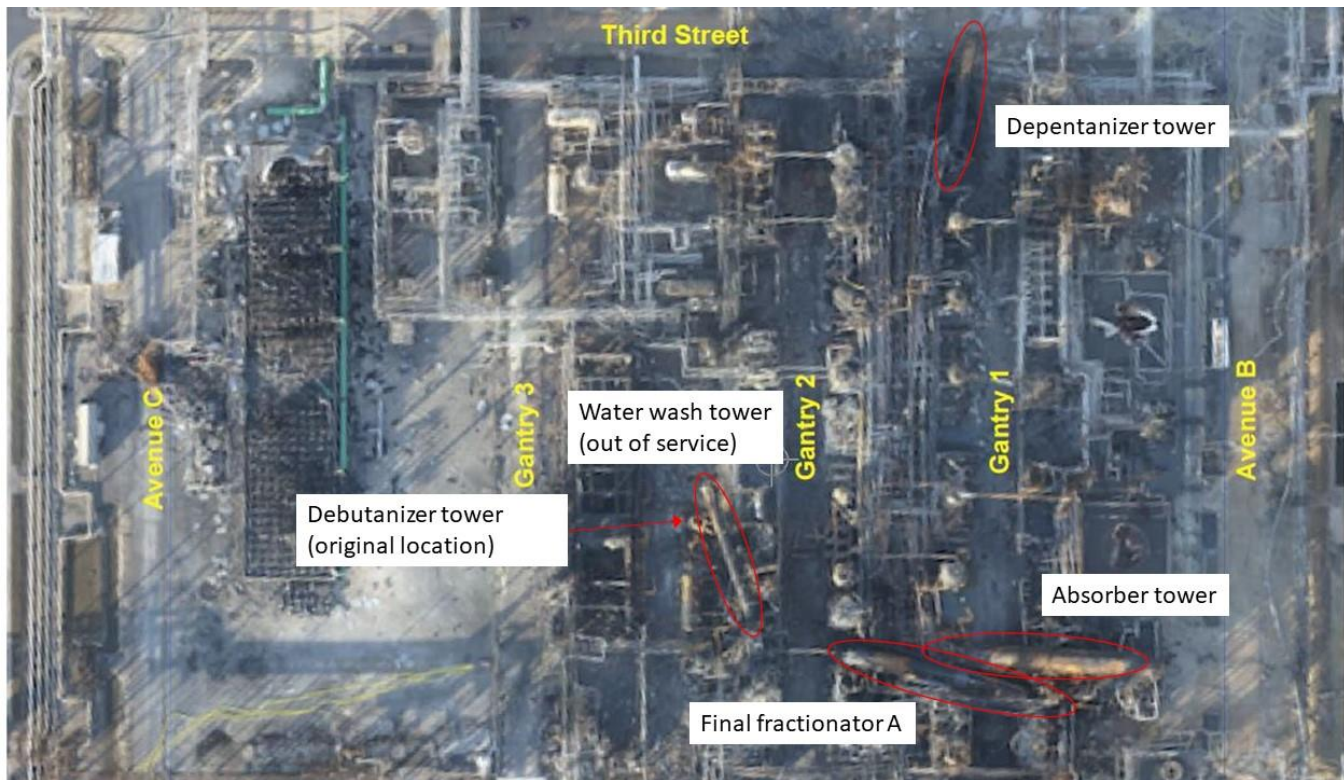
Figure 8. Overhead depiction of TPC PNO South Unit showing the locations of the fallen towers. (Credit: TPC)

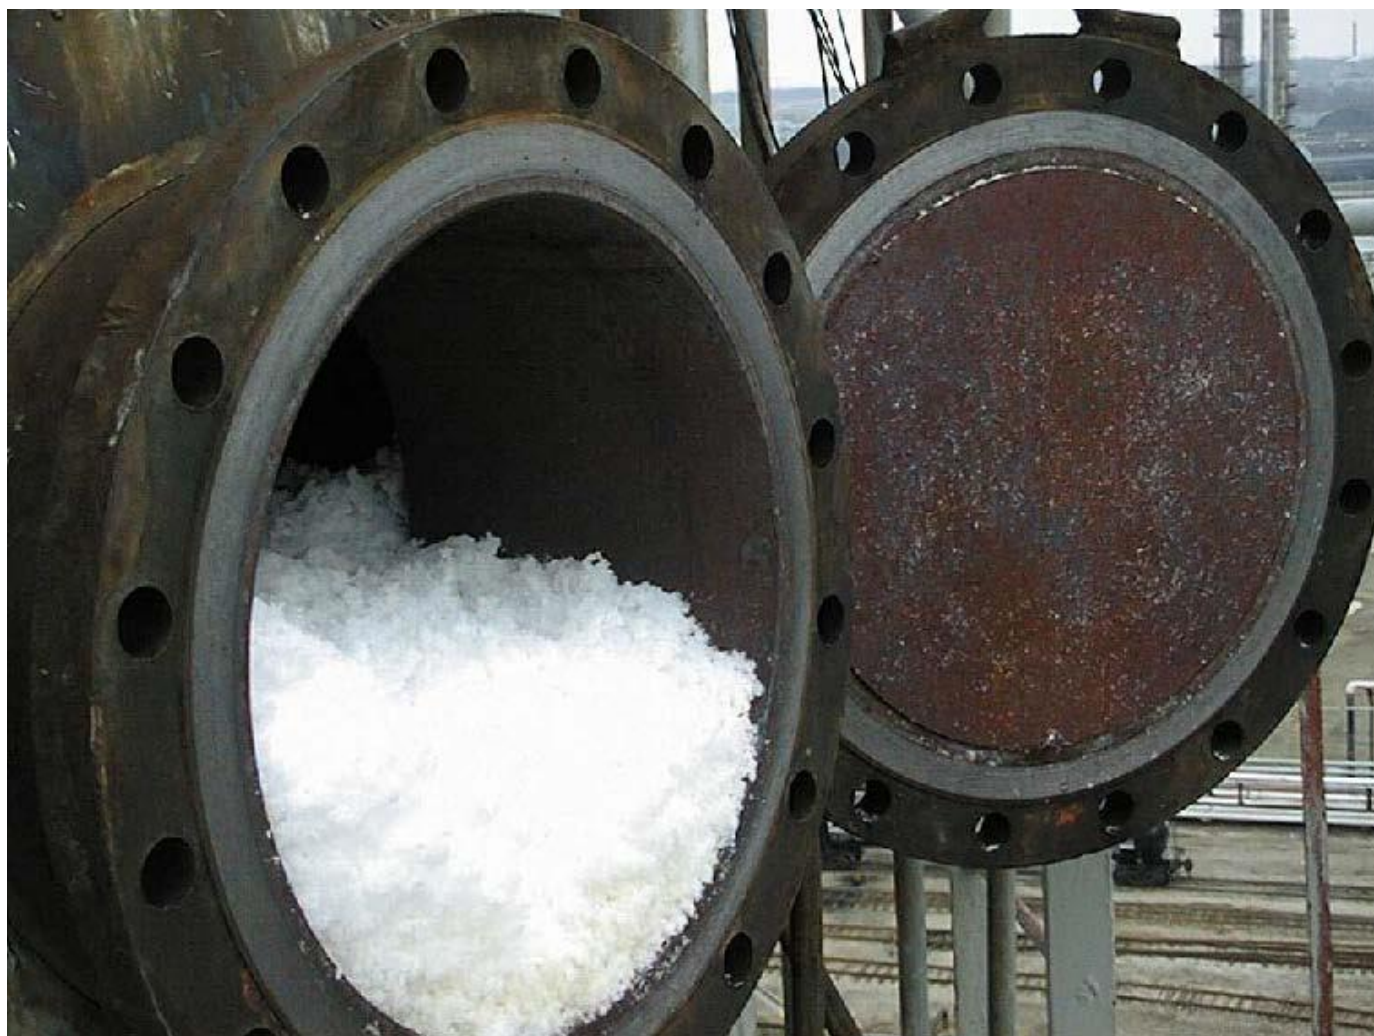
- A solid substance called “popcorn” polymer^a (**Figure 9**) can form in process vessels containing a high concentration of butadiene. Popcorn polymer is a hard, porous, opaque material created when oxygen reacts with butadiene in various areas of a butadiene production plant [11, p. 830]. Popcorn polymer formation involves two phases: initiation (seed formation) and propagation to polymer chains (seed growth) [11, p. 830]. Oxygen reacts with butadiene to form peroxides; butadiene peroxides react with butadiene to form popcorn polymer [8, pp. 8-9].

Figure 9. Popcorn polymer in a manhole from another undisclosed butadiene unit, published in the Butadiene Popcorn Polymer Resource Book. (Credit: International Institute of Synthetic Rubber Producers Inc. [12, p. 261])

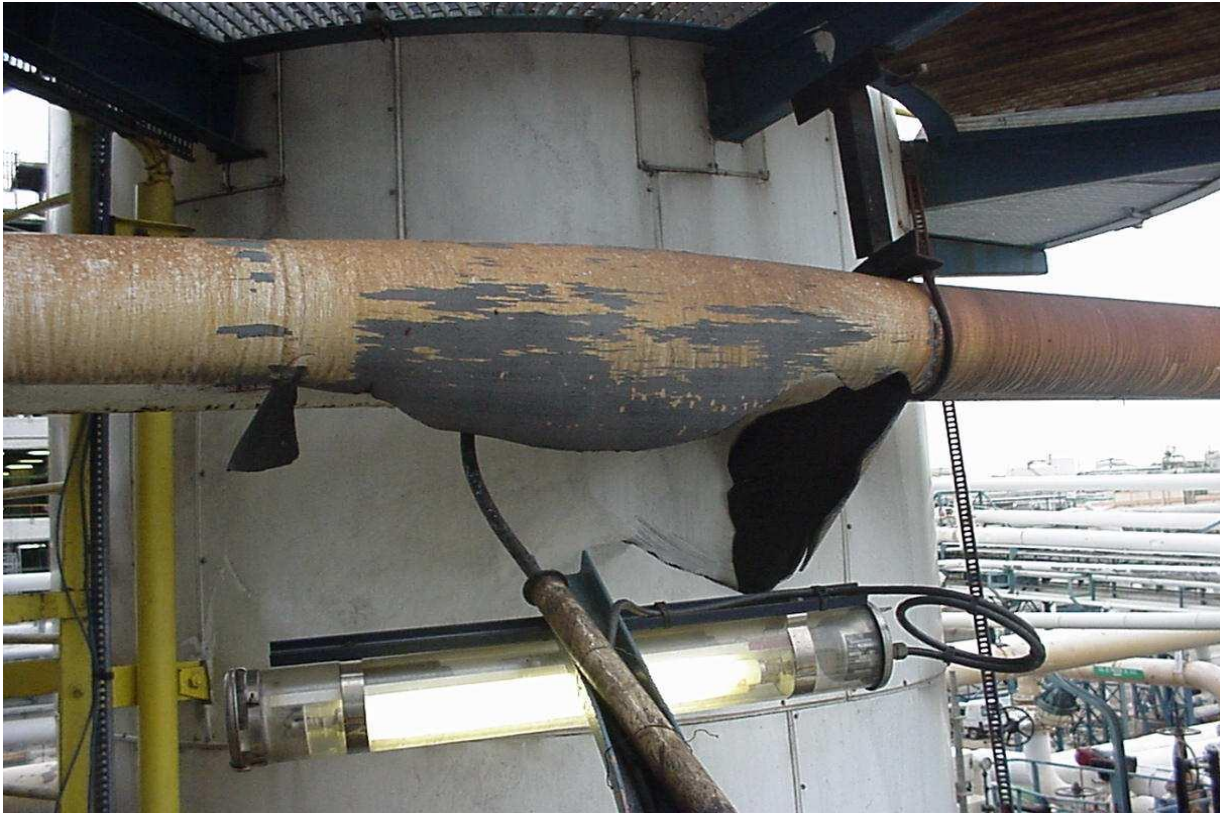
- High internal strain inside the popcorn polymer chains causes them to rupture and form new polymer seeds, thereby increasing the total volume of popcorn polymer as the process repeats [8, pp. 8-9]. This large increase in volume can produce enough pressure to swell or crack steel equipment. Throughout the industry, the buildup of popcorn polymer historically has caused equipment ruptures leading to loss of containment. **Figure 10** shows a pipe rupture caused by the buildup of popcorn polymer in another butadiene unit at the Lavera petrochemical complex located in Martigues, France in 2000 [12, pp. 154-159]. **Figure 11** shows another pipe rupture, which occurred at the PNO facility in 1999.^a

Figure 10. Pipe rupture caused by popcorn polymer in a butadiene unit in the Lavera petrochemical complex. (Credit: French Ministry of the Environment [12, p. 157])

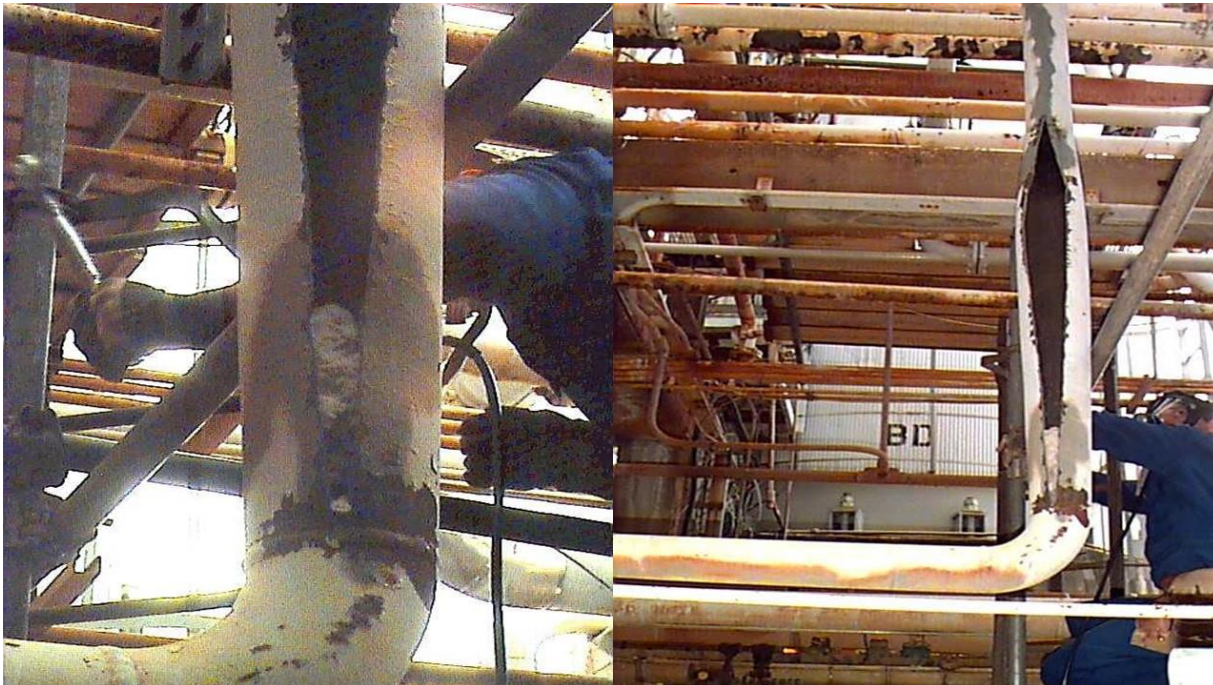
Figure 11. On July 29, 1999, a section of pump suction piping ruptured at the Huntsman PNO facility. Huntsman Corporation owned the facility until TPC acquired it in 2006. (Credit: TPC)

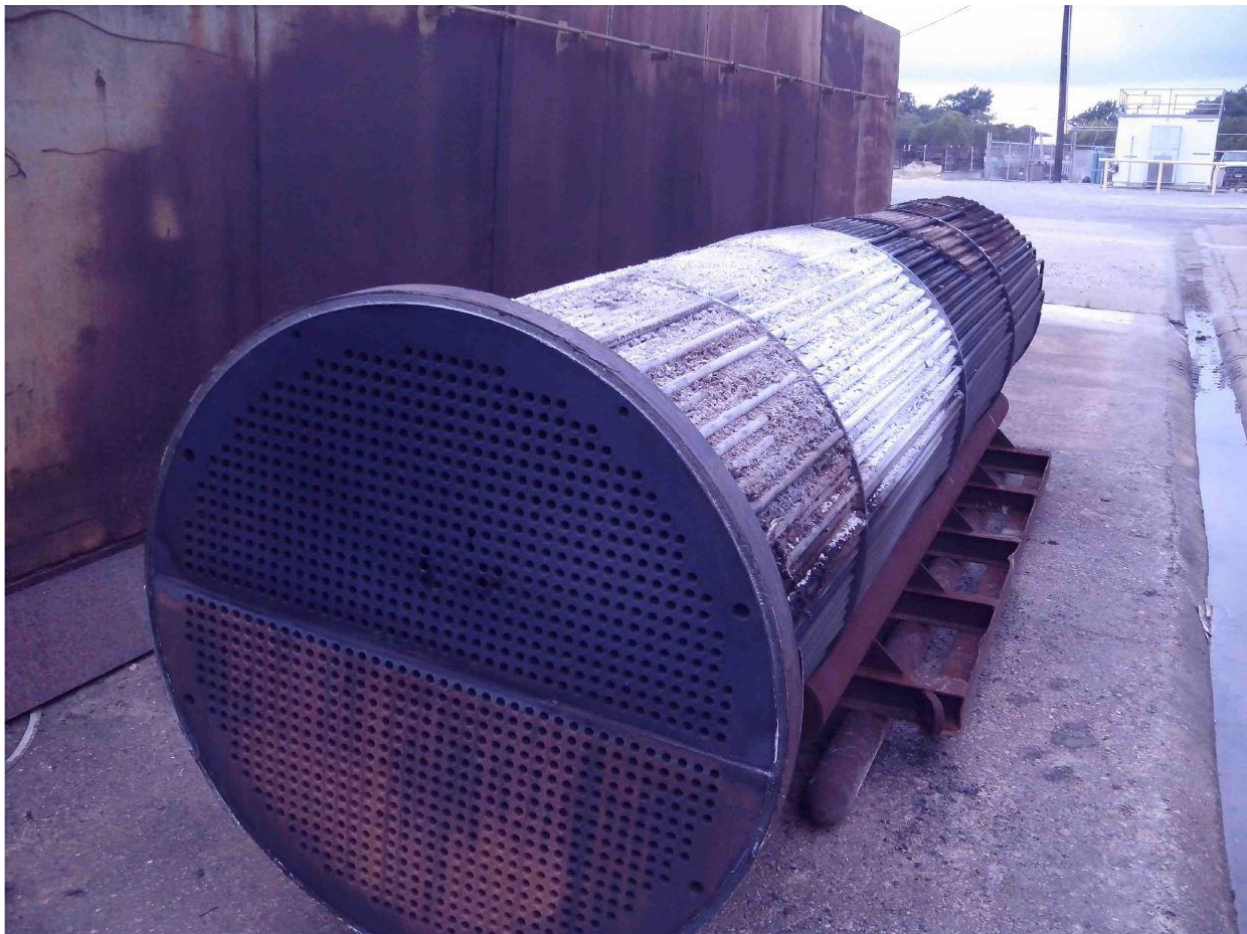
- Popcorn polymer was known to form in the South Unit before the incident. **Figure 12** shows a heat exchanger bundle pulled from one of the methyl acetylene removal tower reboilers on or around September 10, 2019. A TPC employee also noted that the emergency pressure-relief valve on this bundle “was plugged solid with popcorn and polymer.” **Figure 13** shows multiple locations where the TPC PNO facility has experienced polymer fouling problems since July 2019.

Figure 12. Polymer found on methyl acetylene removal tower reboiler bundle pulled on or around September 10, 2019. (Credit: TPC)

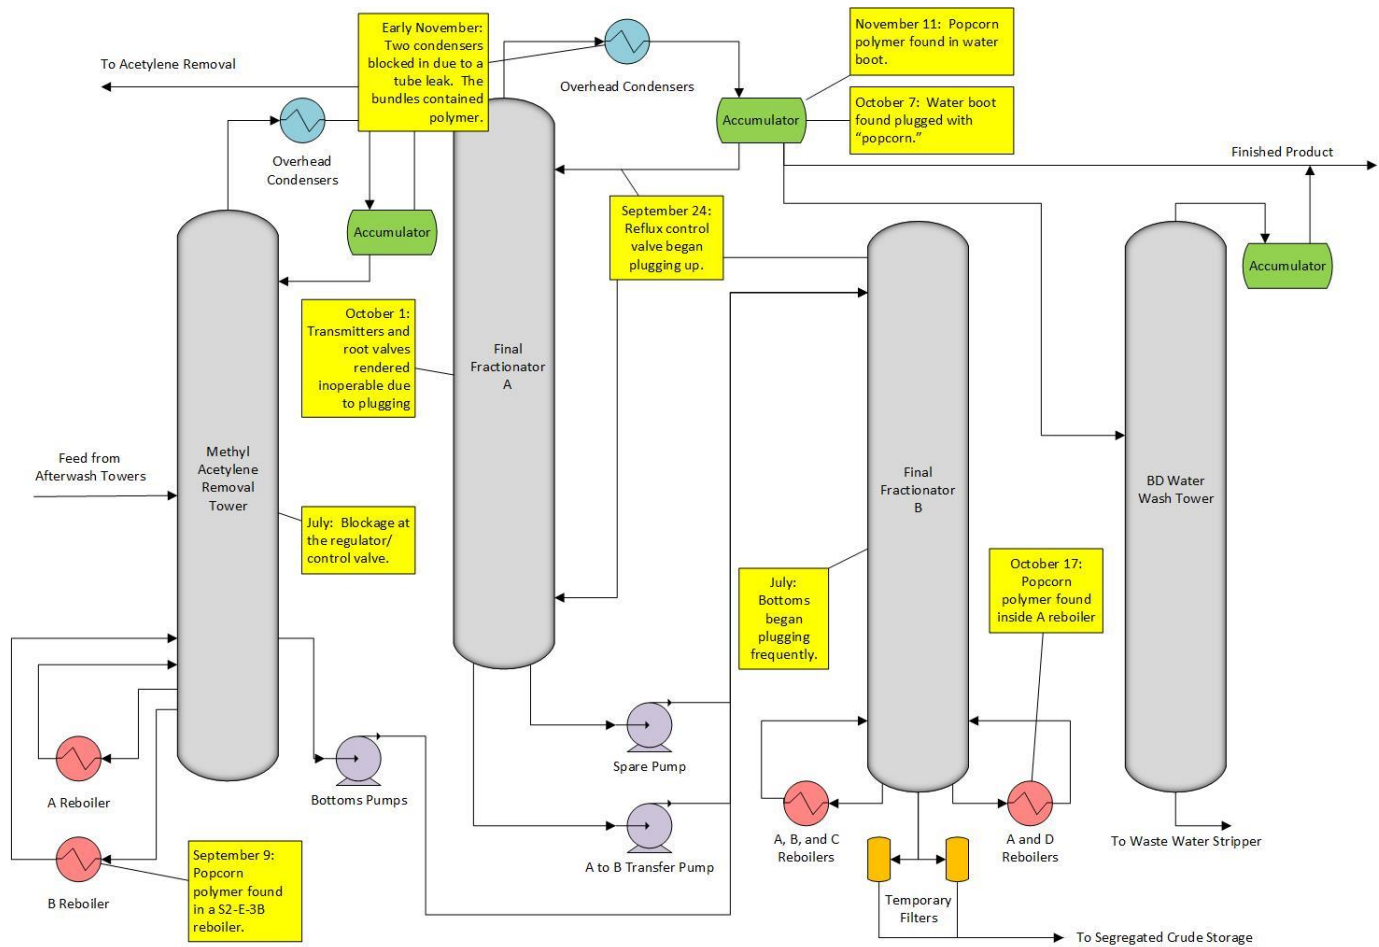
Figure 13. Simplified process diagram showing locations of recent polymer fouling (all dates shown are from 2019). (Credit: CSB)
