Report Title: AB Specialty Silicones Explosion Assessment

Incident: May 3, 2019

Final Report Revision 1

ABS Group Project No. 4282052

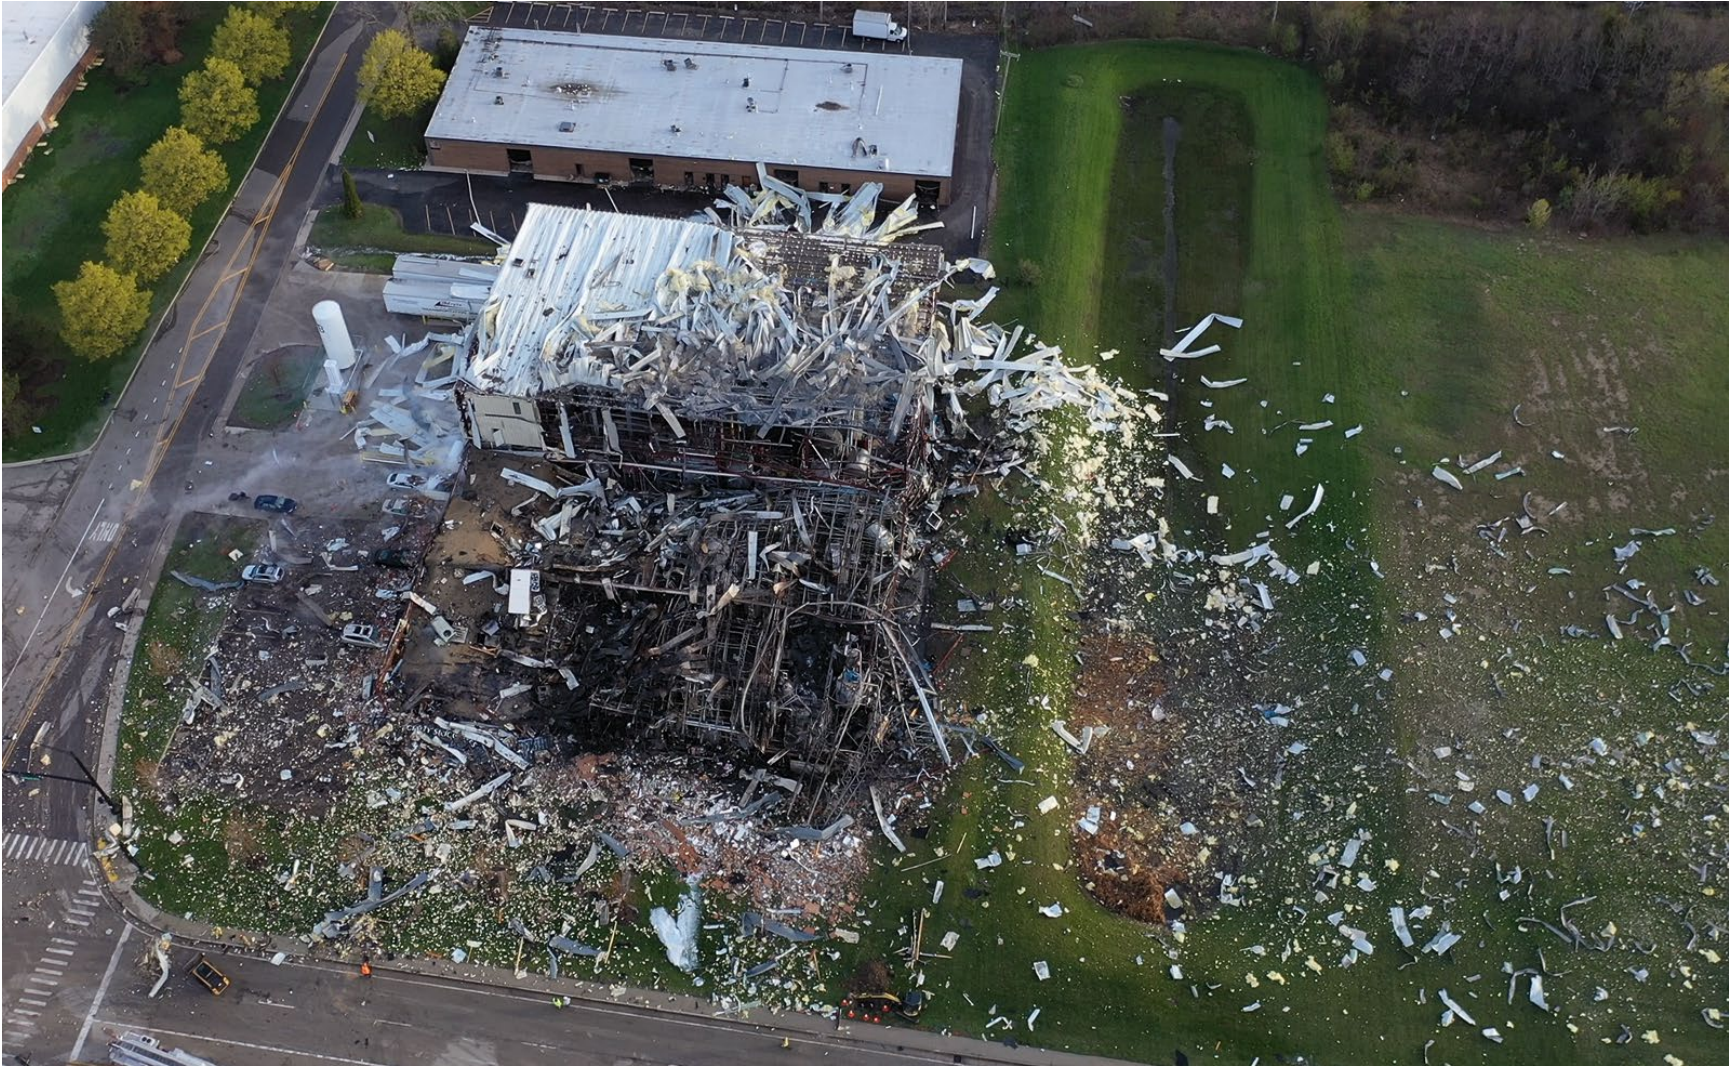
Figure 3-1. Overhead Drone Photo of AB Specialty Facility Collapse

The explosion resulted in the complete structural failure and subsequent collapse of the Low Bay structure. A large portion of the roof was destroyed by the event and the west, south, and east walls were blown outward away from the building creating a significant debris field extending several hundred feet away from the building.

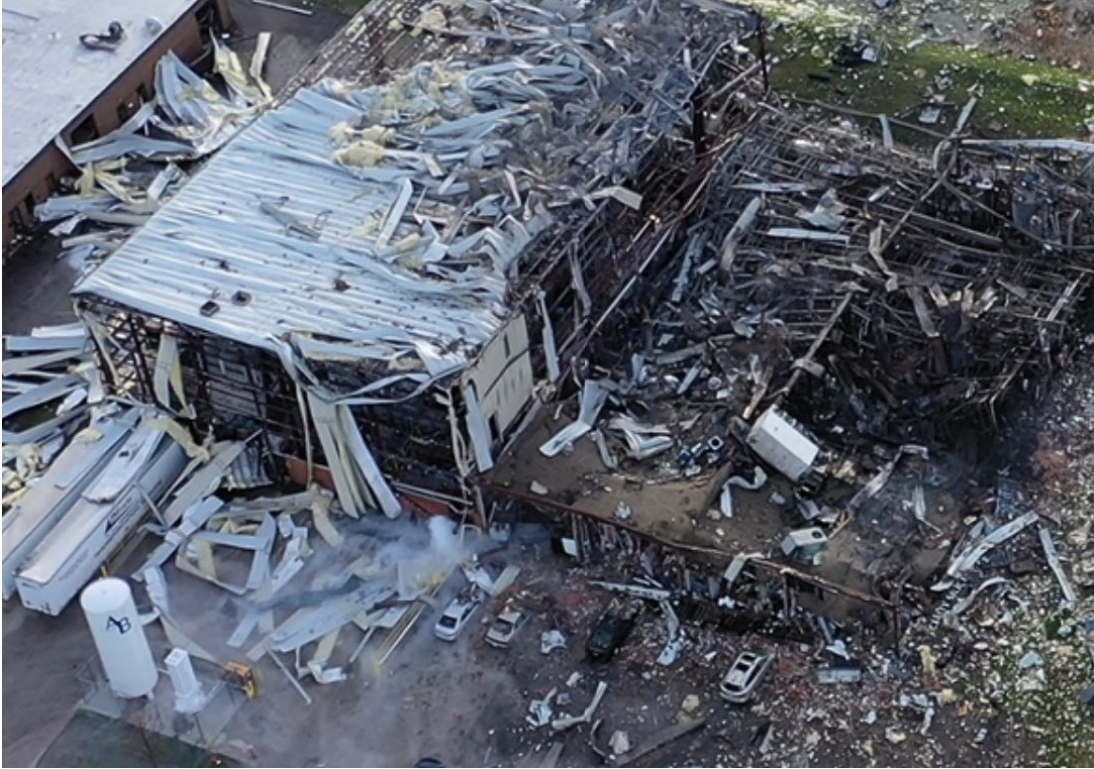
Figure 3-2. AB Specialty Facility Building West Façade

All the metal deck walls of the High Bay were ripped off the girts of the structure by the overpressure. A majority of the girts were deformed outward from the interior of the building. Approximately two thirds of the roof decking were dislodged and thrown from the roof. The southeastern corner of the High Bay was observed to have more significant damage than the remainder of the structure. Girts in this area had larger deformations as well as several experiencing failed connections. An overhead view of the AB Specialty facility damage and collapse is shown below in Figure 3-1, the damage to the west façade is shown in Figure 3-2, and damage to the south façade is shown in Figure 3-3 below.

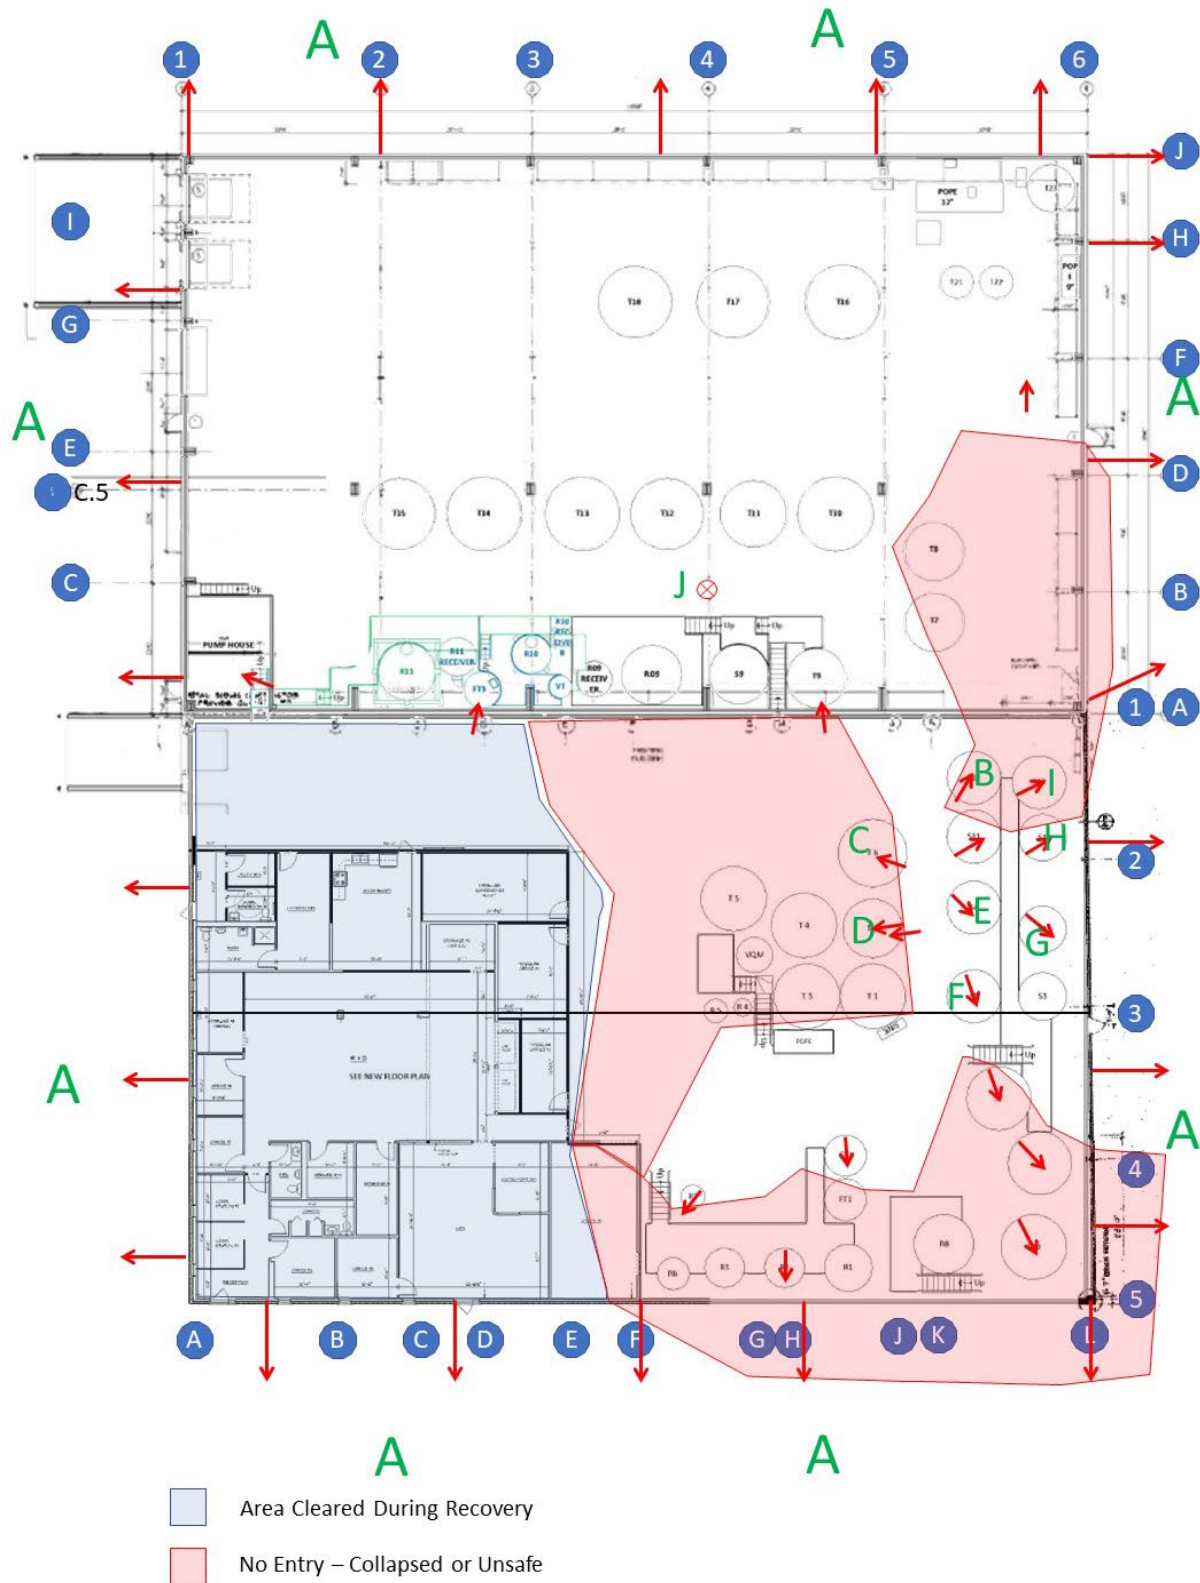
Figure 3-4. AB Specialty Directional Indicator Plan

As a general observation, the directional indicators are consistent with an explosion in the eastern portion of the Low Bay building. Multiple process tanks were damaged on the surfaces facing the area just east of Column Line K and just south of Column Line 2 in the Low Bay. Table 3-1 is a summary of the primary Directional Indicators. Figure 3-4 shows the general floor plan with the Directional Indicators overlaid and examples of directional indicators are provided in Figure 3-5. Photographs of the directional indicators can be found in the Appendix.

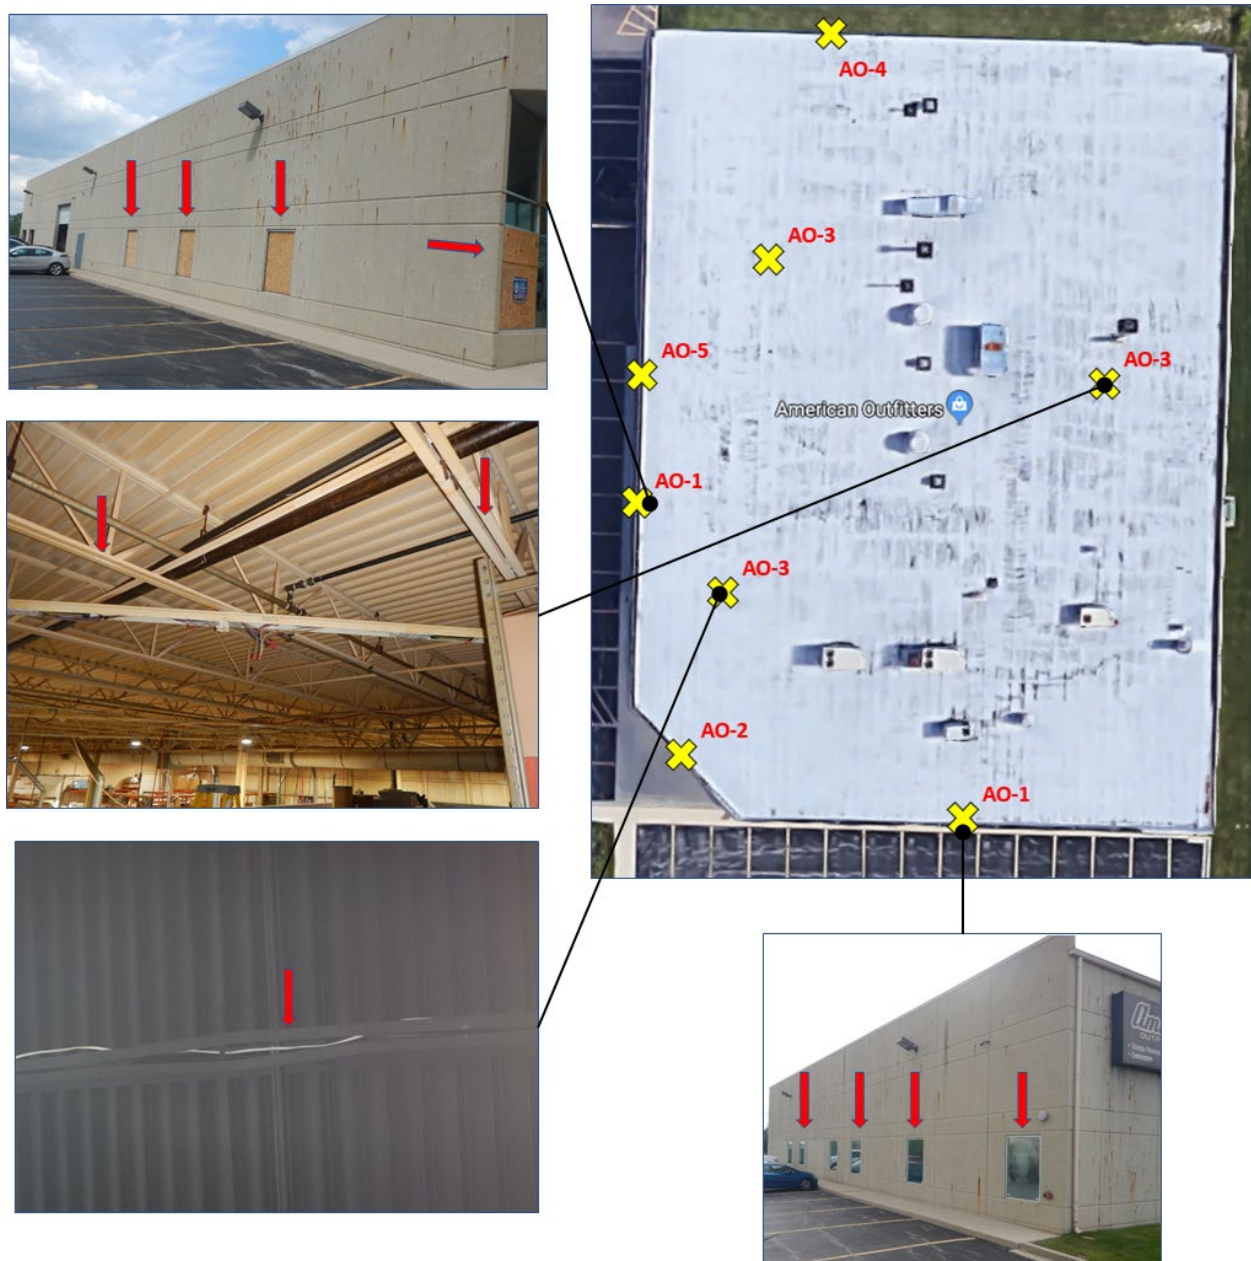
Figure 3-14. Examples of American Outfitters Off-site Blast Indicators

The three off-site locations closest to the AB Specialty facility provided the most suitable far-field blast indicators and included American Outfitters, Eagle Foods, and Woodland foods. At the American Outfitters building, there were broken and unbroken windows along with slightly damaged and undamaged roof joists. Examples of these off-site blast indicators are shown in Figure 3-9.

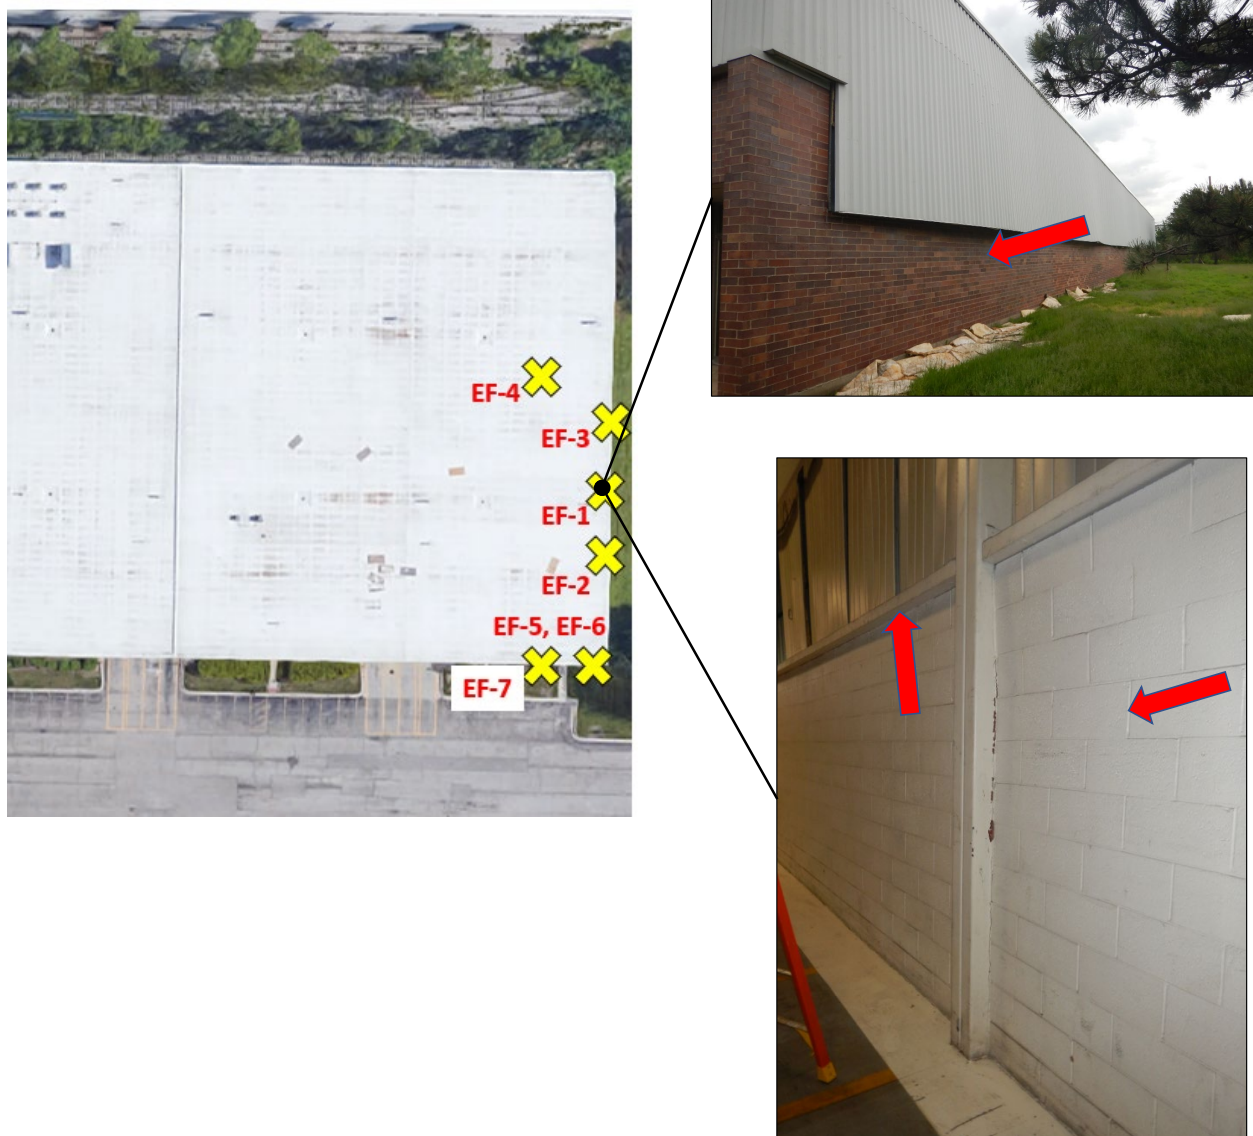
Figure 3-15. Examples of Eagle Foods Off-site Blast Indicators

Two blast indicators from the Eagle Foods building directly faced the ABS Specialty facility were evaluated. The lower portion of the east façade wall was a concrete masonry block walls with a brick façade up to a height of 8 feet. This wall was cracked and permanently deformed from the explosion event. The horizontal steel girt supporting the block walls at the 8-foot height was undamaged. The insulated metal deck wall above the 8-foot girt was deformed heavily and the deformations were too severe to allow it to be included in the blast indicator analysis. Examples of the Eagle Food building blast indicators are shown in Figure 3-15.

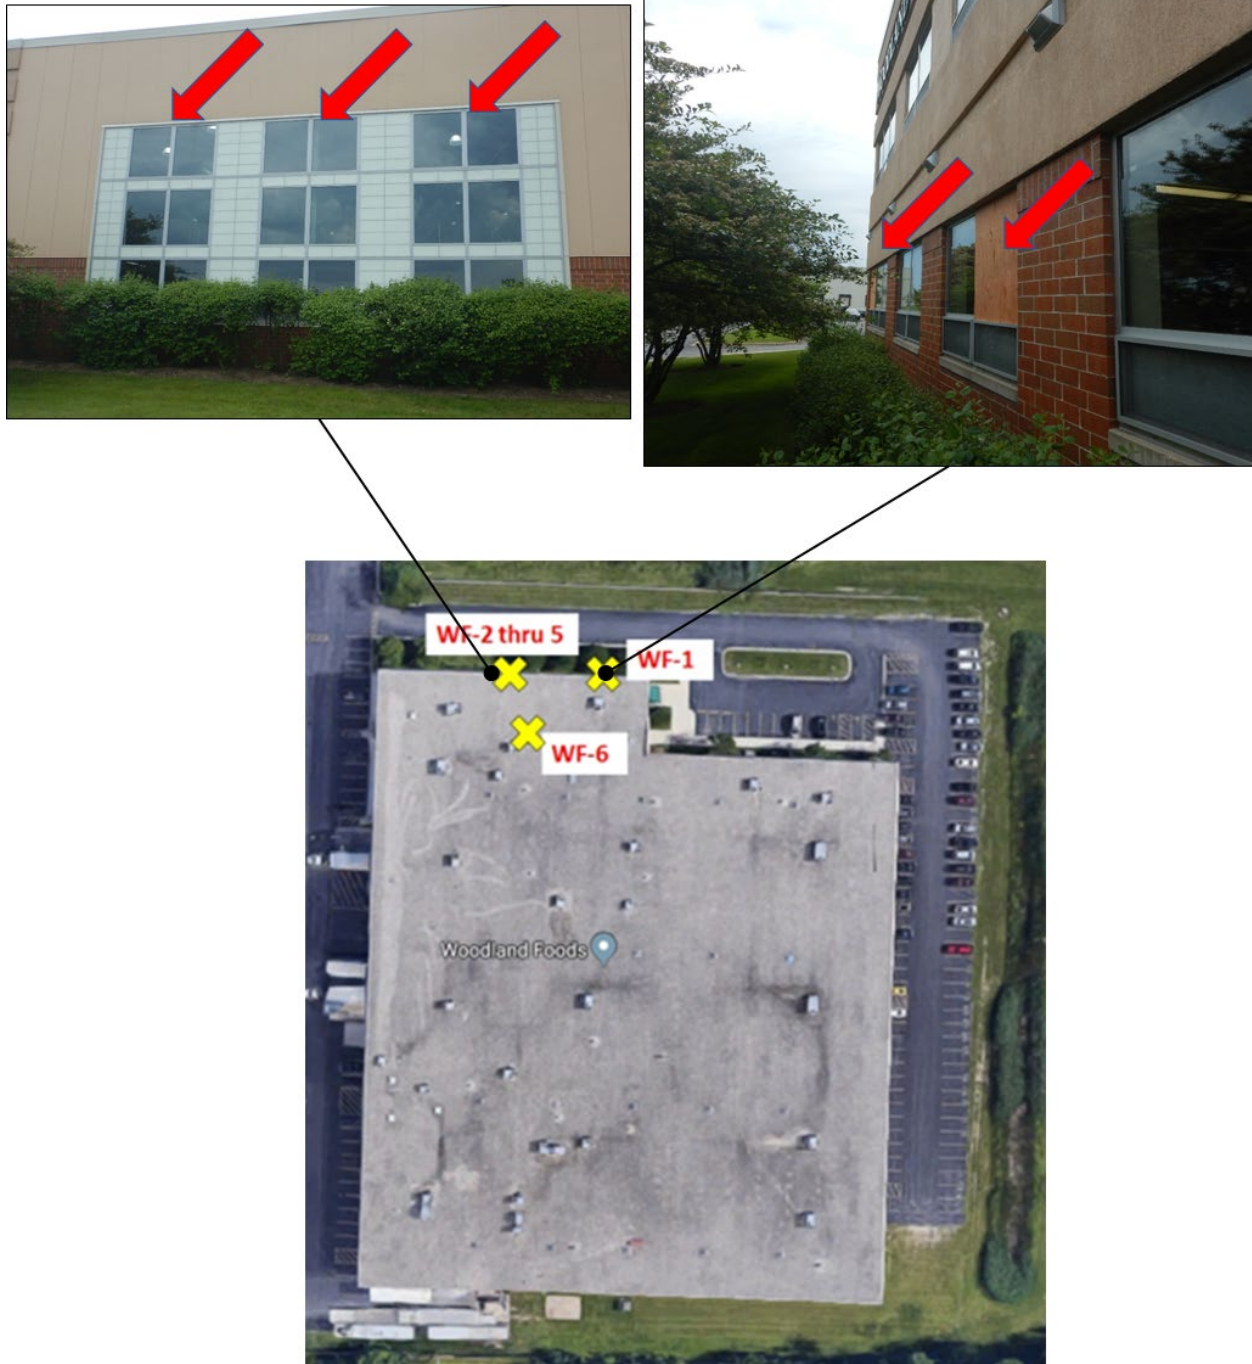
Figure 3-16. Examples of Woodland Foods Off-site Blast Indicators

Windows on the Woodland Foods building were observed to be both broken and unbroken on the north elevation. A few smaller sized windows on the first-floor level near the center of the building (in the east-west direction) were broken while larger windows located in the curtain walls further west on the north elevation were undamaged. Examples of the Woodland Foods off-site blast indicators are shown in Figure 3-16.

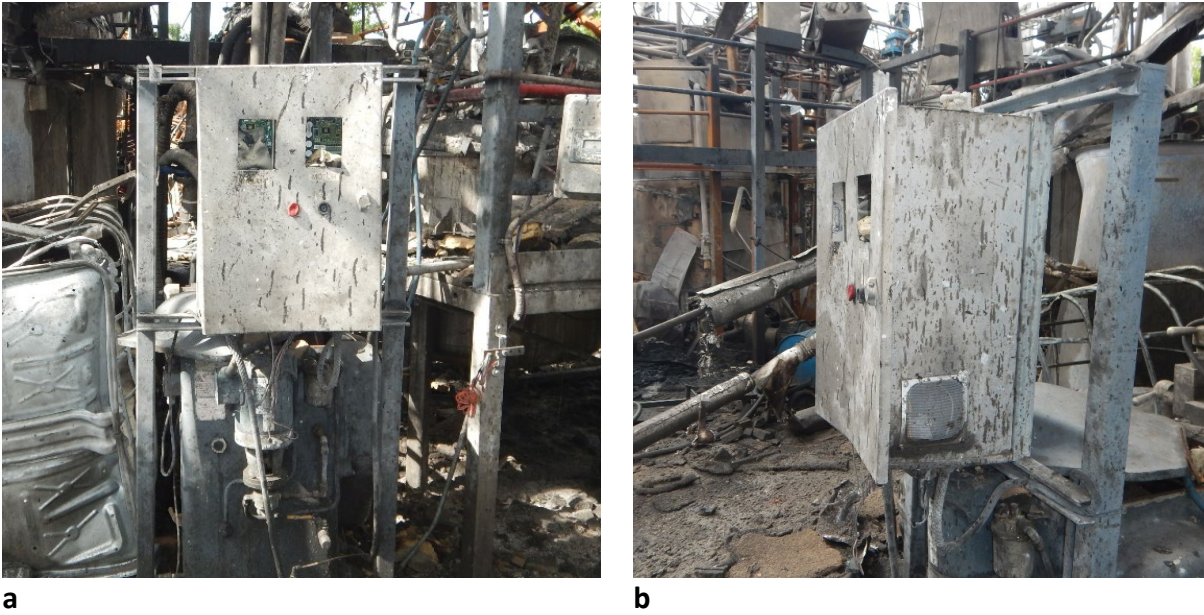
Figure 5-12. Blast Indicator BI-12 North Face - Front View (a) and Side View (b)

Blast indicator BI-12 was an electrical control box in the southwest region of the process area, shown in Figure 5-12. The P-i diagram was created for the control box north face and plotted along with the CFD blast loads in Figure 5-13. The P-i diagram falls between Scenarios 1001, 1002, 1003, 1005, and 1009 (&1009a) plotting below the curve. Scenarios 1004, 1006, 1007(&1007a), and 1008 plotting above the line. Scenario 1004 is essentially closest to the P-i curve as measured in log space. However, the control box was supported by two square tubing vertical struts cantilevered from the floor. The struts would also have bent away from the blast absorbing energy and reducing additional blast to create the damage to the front control panel. This resulted in consistency with Scenarios 1006, 1007, and 1008 for this specific comparison.

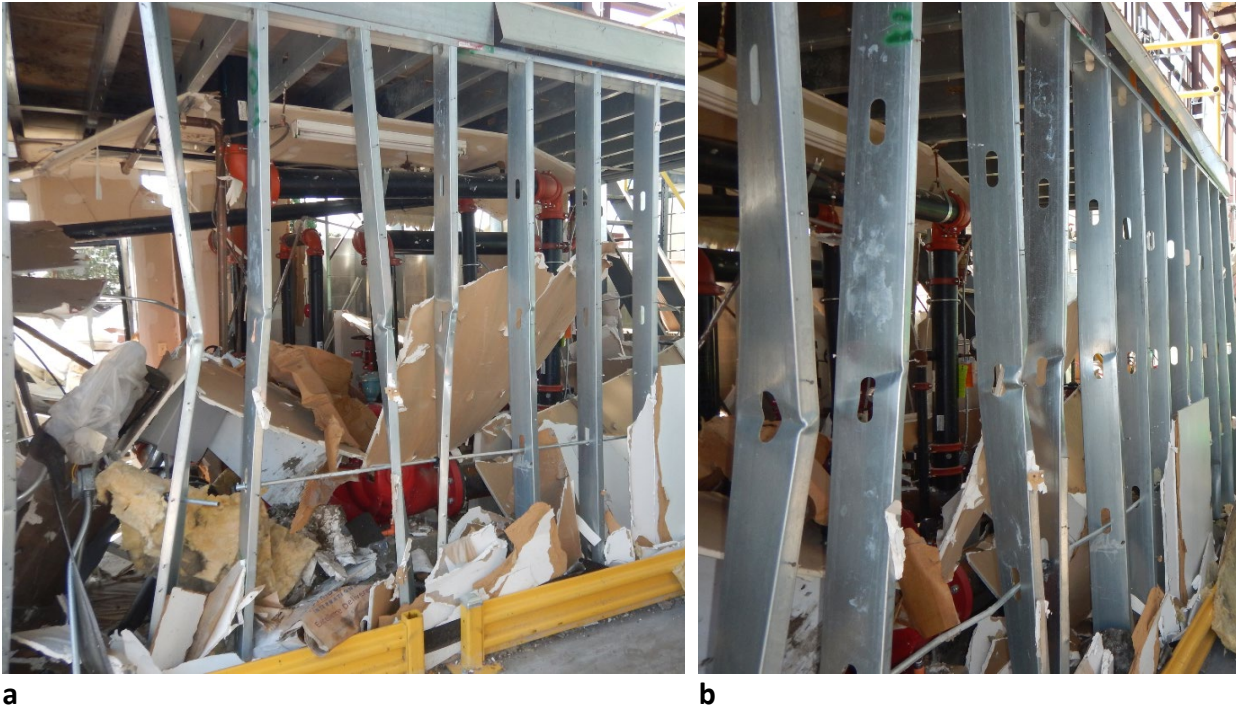
Figure 5-14. Blast Indicator BI-8 East Face - Front View (a) and Side View (b)

Blast indicator BI-8 was metal wall studs located on the southwest corner of the High Bay adjacent to the connection to the Low Bay. The metal stud wall is shown in Figure 5-14. This blast indicator is unique in that the two P-i diagrams were generated for the observed damage (two different studs with slightly different damage) could be plotted on the same chart and compared to the same applied blast loads, due to the close proximity of their location and orientation within the High Bay. The intersection of the two P-i diagrams, shown below in Figure 5-15, indicated the theoretical blast pressure and impulse at the location of blast indicator BI-8. It is noted that Scenarios 1007(&1007a) and 1008 are the most proximate to the two curves with Scenario 1006 just below.

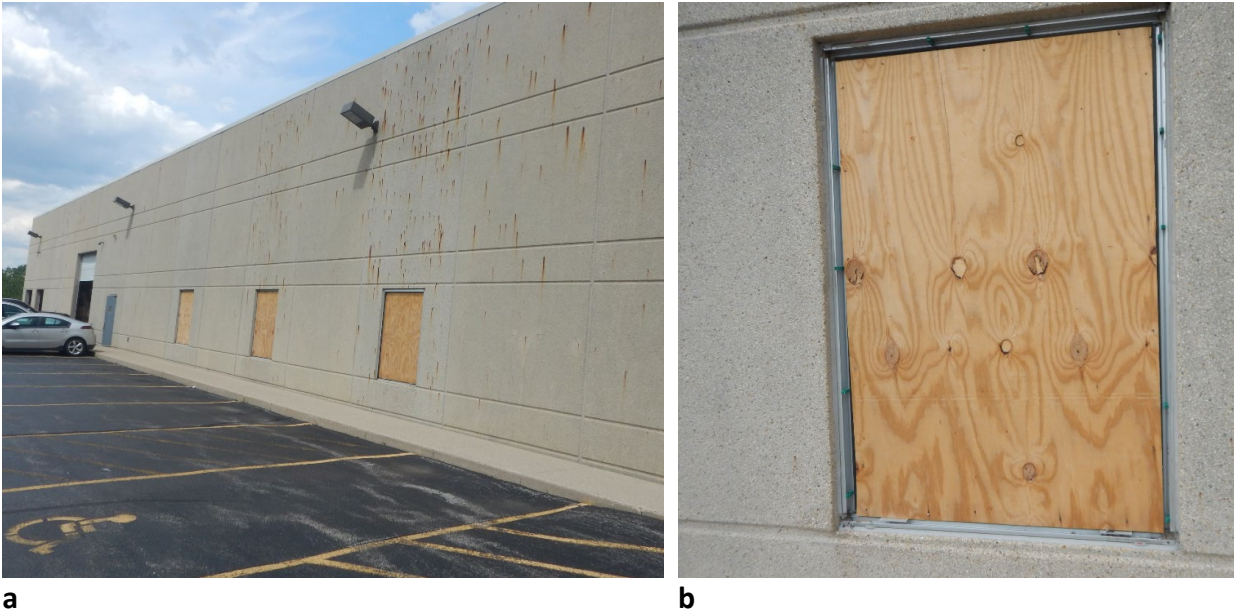
Figure 5-19. Blast Indicator AO-1 West Elevation - Elevation View (a) and Close-in View (b)

Off-site blast indicator AO-1 was a set of windows on the west face of the American Outfitters building as shown in Figure 5-19. Glazing in the windows was an insulated glass unit (IGU). All the windows on this face of the building were broken. Most of the broken glass was reported to be lying on the ground outside of the building after the explosion. This indicates that the blast wave was strong enough to break the windows but not energetic enough to accelerate and propel the glass into the building. Two P-i diagrams were developed for the typical window in the west elevation of the building. The first set of P-i data represent the threshold for breakage (Condition 1-2) of the window glazing and the second represents threshold for glass debris beyond 1 meter (Condition 2-3a) into the building. The P-i diagrams and explosion scenario blast loads at this location are shown in Figure 5-20. Only Scenarios 1006, 1007(&1007a), and 1008 showed pressure and impulses over the window breakage threshold. The higher blast loads of Scenario 1008 would indicate that the glass would have been propelled more into the building than was observed. Thus, Scenarios 1006 and 1007(&1007a) are most consistent with the window damage observed at this location.

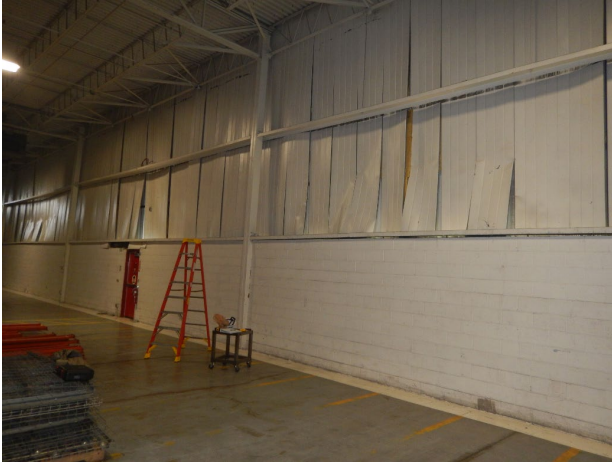
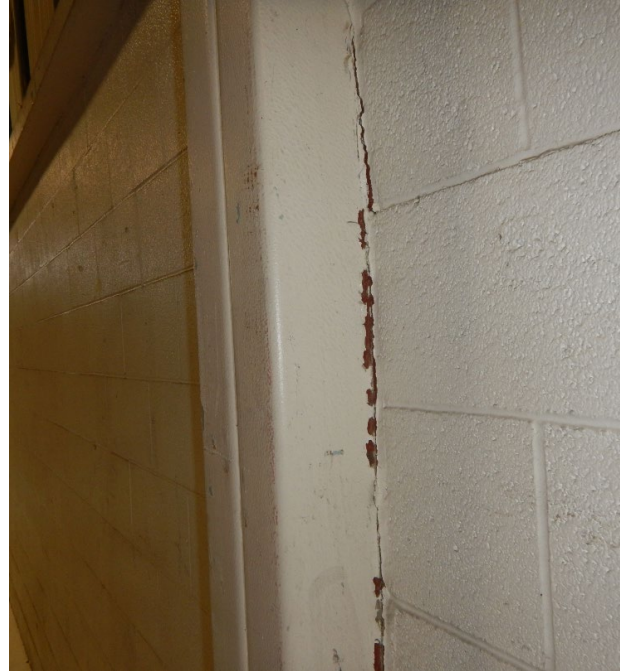
Figure 5-21. Blast Indicator EF-1 East Elevation - Elevation View (a) and Close-in View (b)

Off-site blast indicator EF-1 was an unreinforced concrete masonry unit (cmu) wall with brick veneer on the lower portion of the east elevation of the Eagle Foods building, shown in Figure 5-21. Eagle Foods is located to the west across Northwestern Avenue from the AB Specialty facility. Blast indicator EF-2 was a hot rolled steel girt supporting the top of the cmu wall at about 8 ft above the floor slab and supporting the metal wall panels above shown in Figure 5-22. Two sets of P-i data were developed for the cmu walls; the threshold of damage and observed damaged curves. The steel girt did not show signs of permanent damage, so, a threshold for damage curve was used for comparison with CFD applied loads. Figure 5-23 shows the P-i diagrams and CFD applied loads for the cmu walls and steel girt. Scenario 1001 blast loads are close to the cmu wall damage threshold curve. Scenarios 1002, 1004, 1005, 1009(&1009a) loads exceed the observed cmu damage curve and not consistent with the damage. Scenarios 1006, 1007(&1007a), and 1008 are the most consistent with undamaged cmu blast indicator. All the scenarios are below the threshold of damage for the steel girt which is consistent with lack of permanent damage to the member.
