December 2018

On April 26, 2018, an explosion (Figure 1) and subsequent fire (Figure 2) occurred at the Superior Refinery Company LLC refinery in Superior, Wisconsin (“Husky Superior Refinery”).¹ The incident occurred in the refinery’s Fluid Catalytic Cracking Unit (FCCU). As a result of the explosion, thirty-six people sought medical attention, including eleven refinery and contract workers who suffered OSHA recordable injuries. In addition, a portion of Superior,² Wisconsin was evacuated. Evidence collected to date suggests similarities with a previous investigation of the February 18, 2015 explosion at a refinery in Torrance, CA.

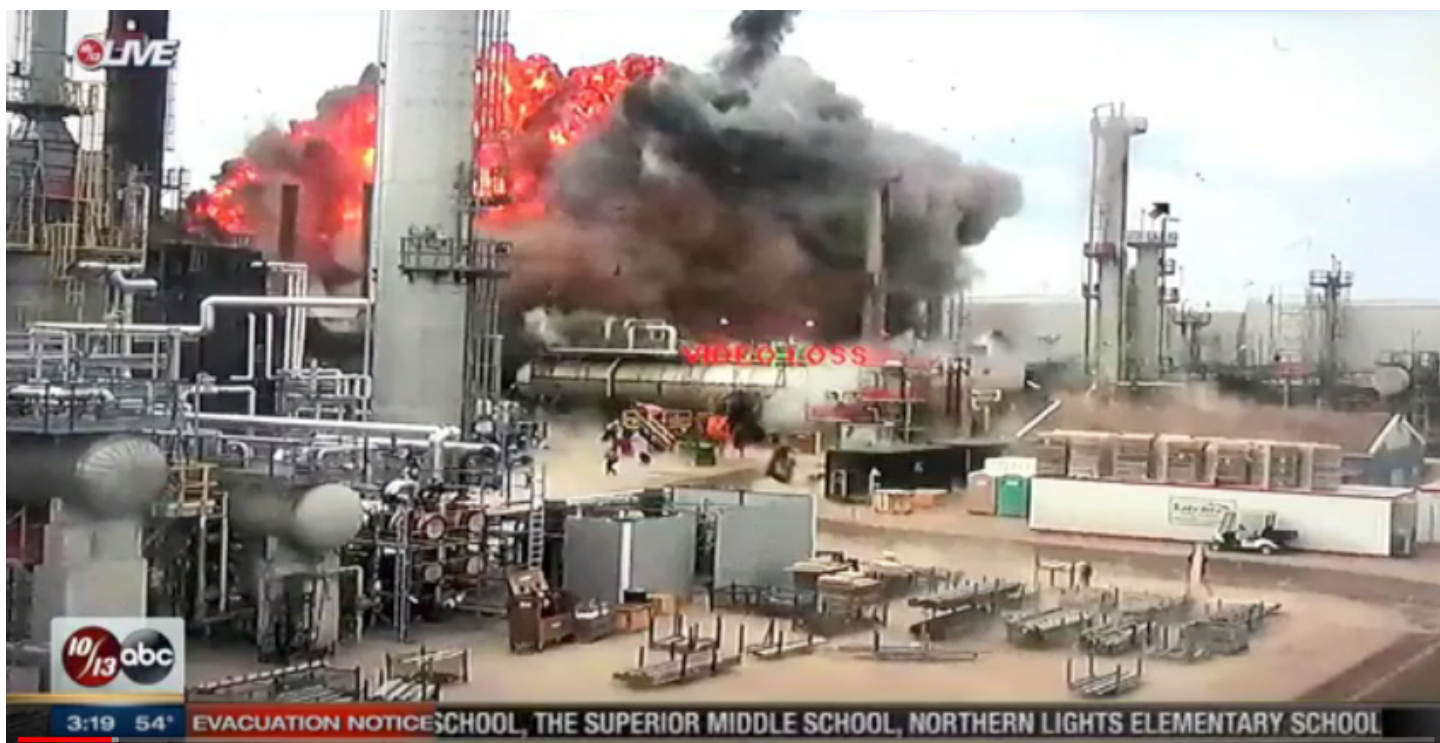
Figure 1. Surveillance Camera Image of the Husky Superior Refinery Explosion. Credit: WDIO ABC News.

Both the Superior and Torrance explosions resulted from the inadvertent mixing of hydrocarbons with air inside the unit that found an ignition source, resulting in an explosion. In the Torrance explosion, hydrocarbons flowed backward into the air side of the FCCU. In the Superior explosion, air flowed forward into the hydrocarbon side of the FCCU. In both cases, explosion debris impacted equipment in surrounding units and caused subsequent fires and releases to the atmosphere.

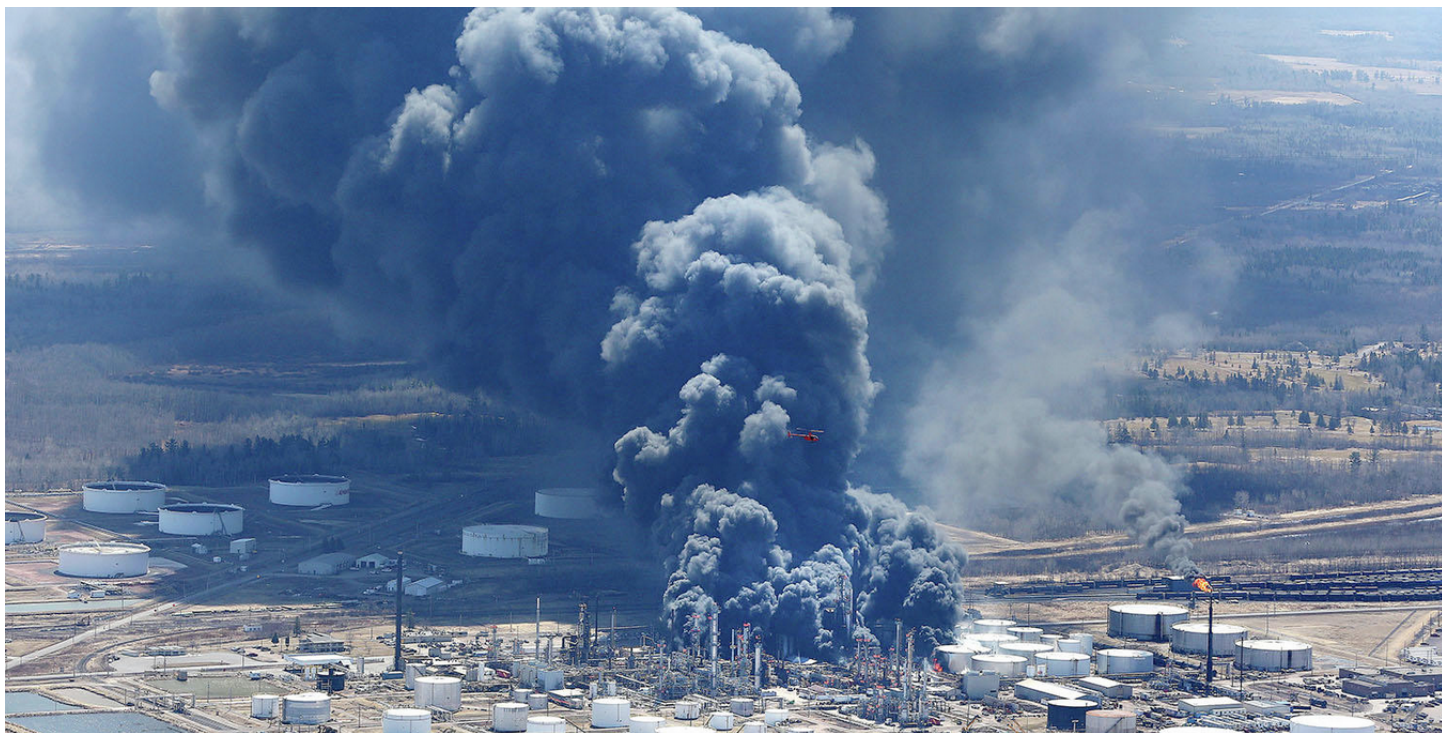
Figure 2. Smoke from the Fire at the Husky Superior Refinery. Credit: WDIO ABC News.

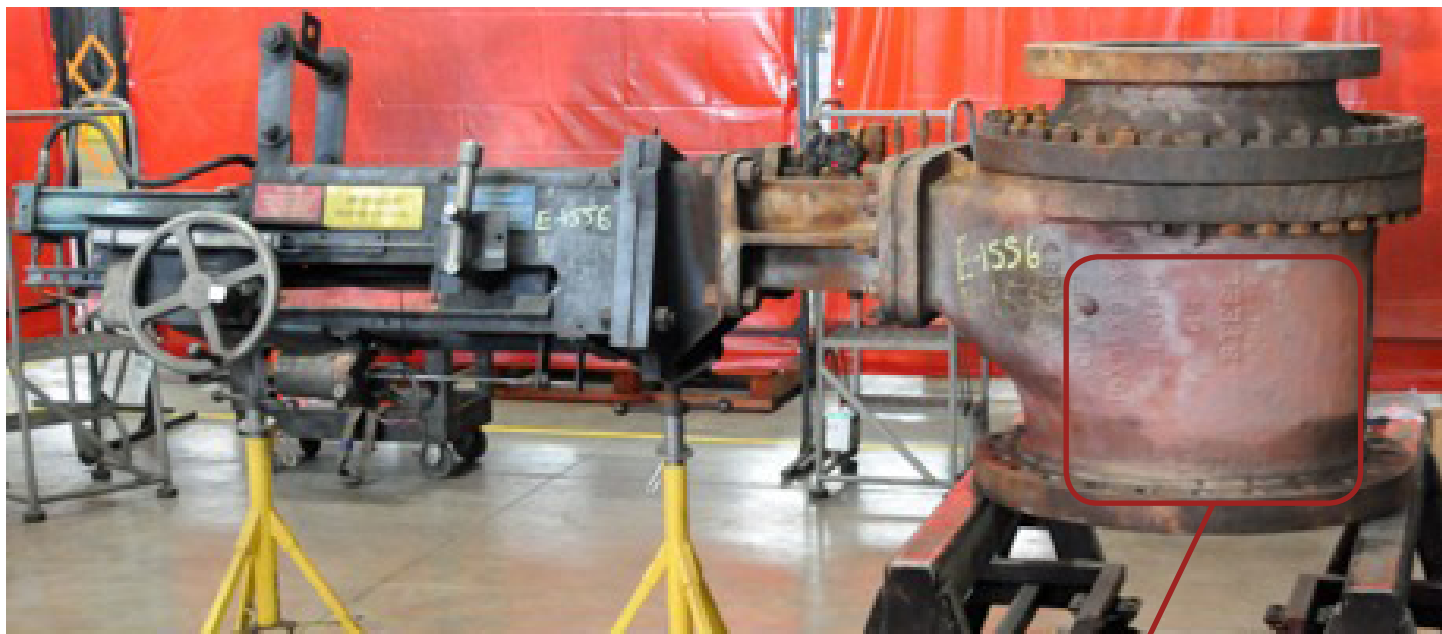
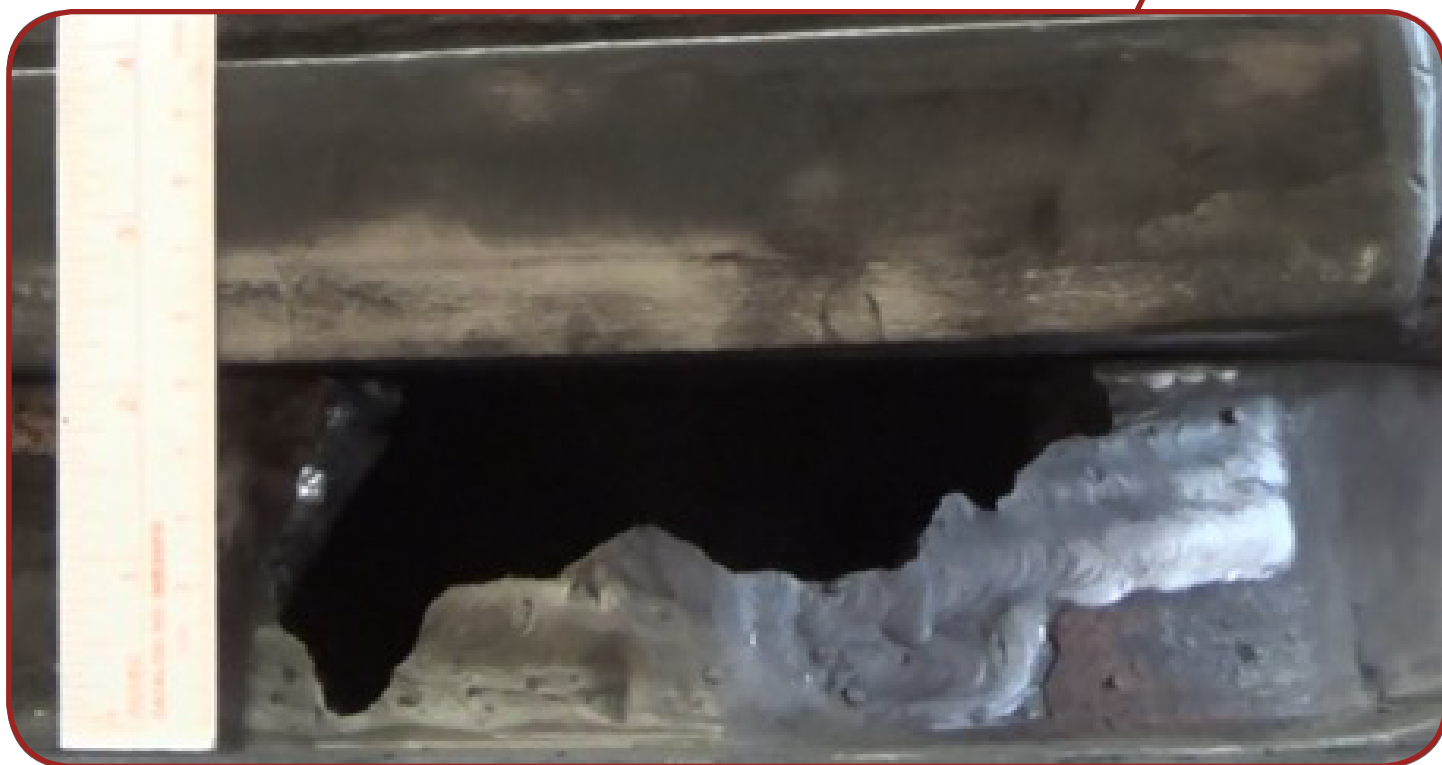
Both incidents involved the company relying on a SCSV to maintain a barrier between the hydrocarbon and air sides of the FCCU during non-routine operation. The CSB has determined that the FCCU SCSV used at the Superior refinery was "designed for complete shut-off of flow" and that even though it was subject to erosion from the FCCU catalyst, it was intended to be "provided with erosion protection suitable for the design life at the design conditions." Despite this, the FCCU SCSV was unable to maintain a catalyst level to prevent air from mixing with hydrocarbons in the FCCU during the shut-down (**Figure 3**).

Figure 3. The Husky Superior FCCU SCSV post-incident. The top picture shows the entire valve assembly and the bottom picture shows the eroded orifice port.

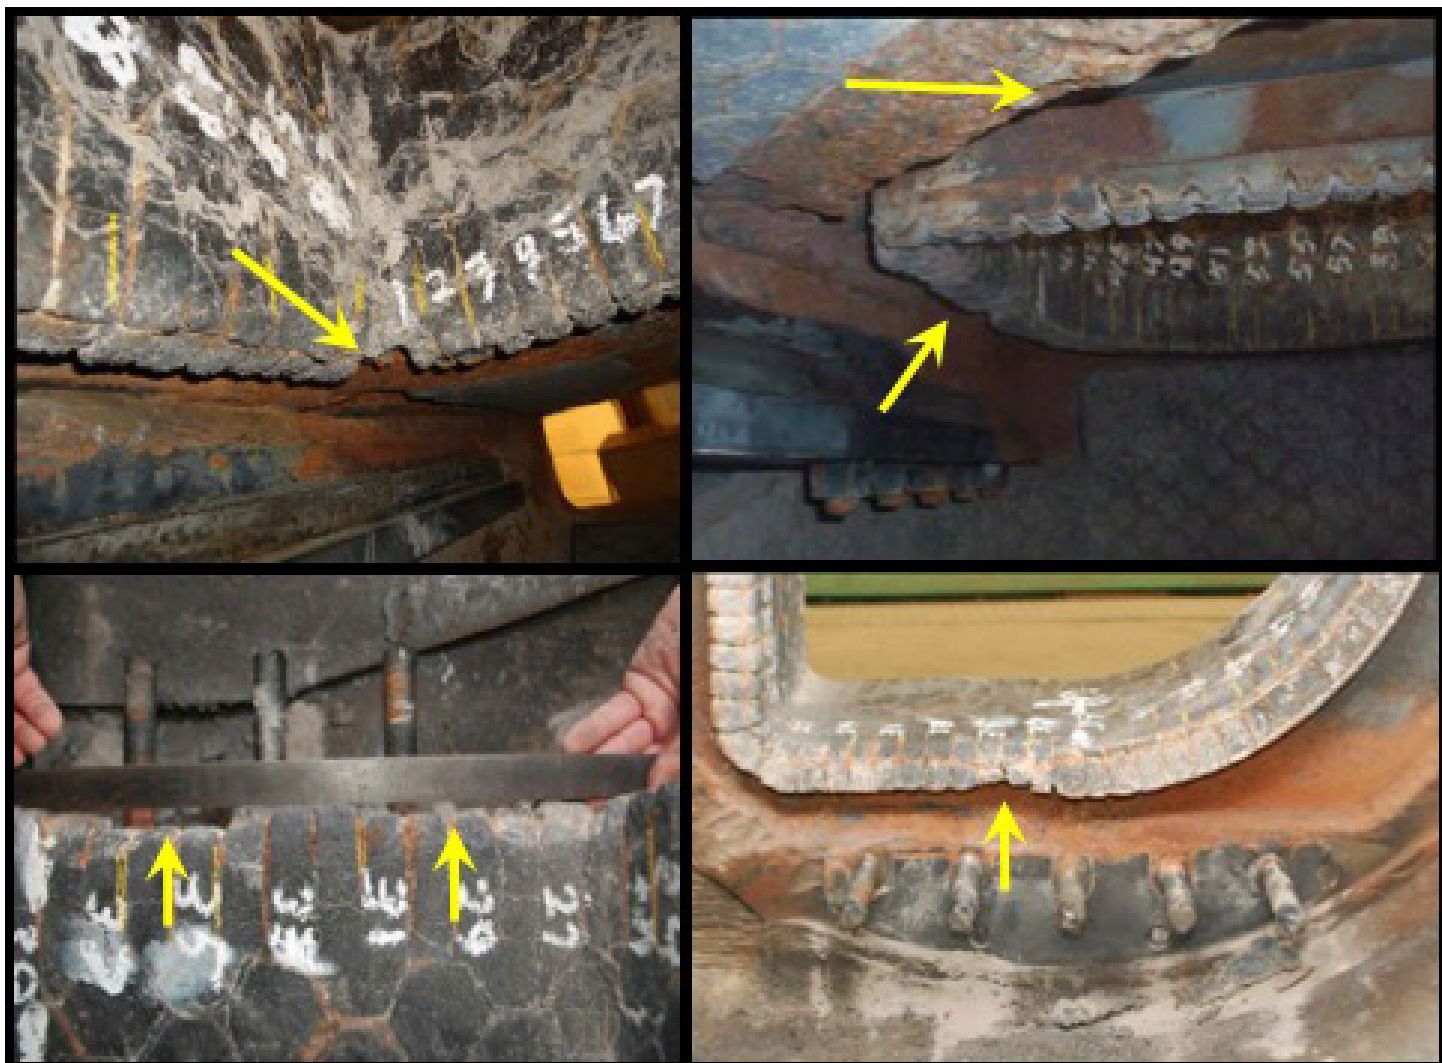
In its investigation of the Torrance incident, the CSB inspected the internal components of the SCSV. The inspection found the valve internals eroded to the point that the valve could not seal (**Figure 4**). An area of approximately 16 square inches eroded away during six years of operation, providing an open path for catalyst to flow through the valve even when in the fully closed position. The

erosion prevented the closed SCSV from developing the necessary catalyst barrier on the day of the incident.

Figure 4. Torrance Refinery SCSV post-incident. The yellow arrows show the erosion in the valve.

The CSB's Torrance investigation also recommended that the Torrance refinery make changes to the way safety critical equipment, such as the SCSV, was maintained and to ensure that there were operating procedures for each mode of operation. After the incident, the Torrance refinery stated that the refinery conducted a review of the FCCU safety critical devices and implemented the following:

- Identification of all safety critical equipment;
- Consequences of failure for each mode of operation;
- Evaluated and established parameters, limits, and associated equipment to ensure an appropriate steam-induced

pressure barrier for FCC Emergency Shutdown and Safe Park procedures;

- Updated Emergency Shutdown and Safe Park procedures to address the loss of catalyst seal, loss of steam barrier, and failure of the ESP to de-energize; and
- Evaluated additional isolation facilities between the main column and the flue gas system.
- The Torrance refinery also formed a cross-functional team of experts and developed an FCCU Safe Park procedure and updated the FCCU Normal Shutdown, Emergency Shutdown, and Start-up procedures for the Torrance Refinery. The Torrance refinery reviewed areas of higher risk or with a higher vulnerability through an independent risk assessment to ensure that adequate layers of protection were in place during stand-by mode and other operation modes.
