Key Lessons for Preventing Incidents When Preparing Process Equipment for Maintenance

Flash Fire at the Delaware City Refinery

Delaware City, DE

No. 2015-01-I-DE

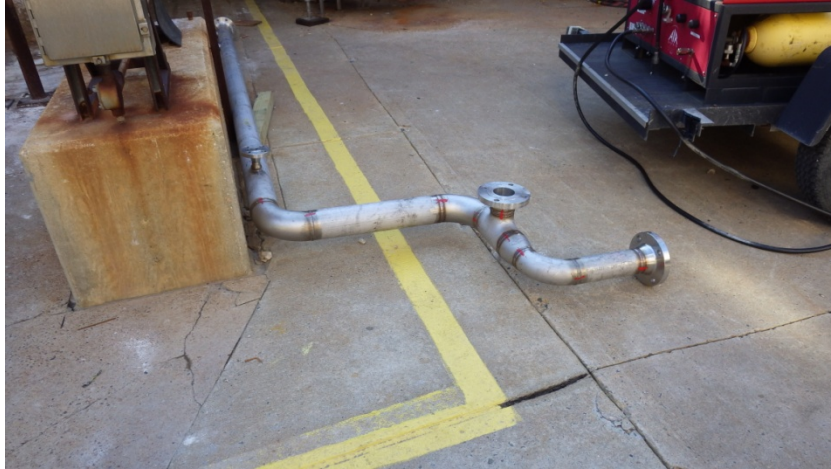
FIGURE 2. 20-foot replacement piping (Source: CSB).

On the day of the incident, alkylation unit operators were preparing equipment for turnover to the maintenance department, scheduled for the following day. The unit remained under the operations staff control throughout the equipment preparation activity, up to and including when the incident occurred. The maintenance activity involved replacing a 20-foot section of thinning piping located between the caustic settler drain line and the caustic recirculation pump (Figure 1) that was identified during a routine inspection process a month prior (Figure 2).

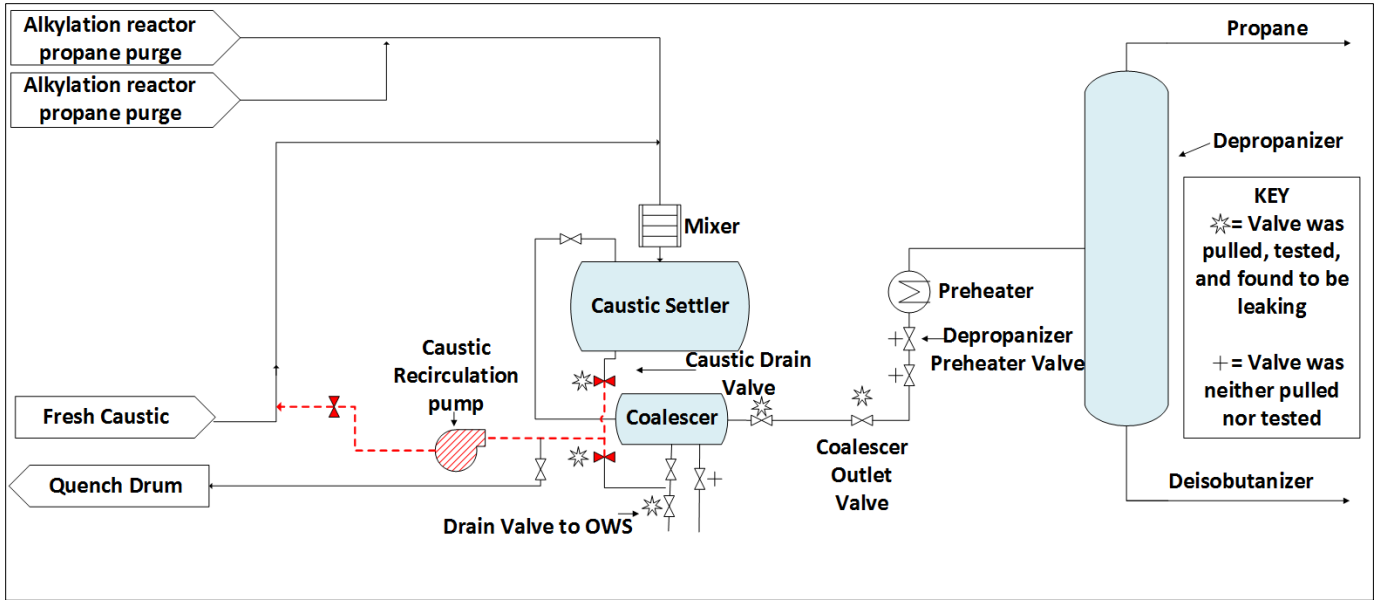
FIGURE 3. Original isolation plan shown in red (Source: CSB).

Because the valve would not seal, operations could not isolate the section of piping that needed replacement and therefore had to expand the isolation to another block valve downstream of the coalescer and settler. As a result, the caustic settler and the coalescer needed to be included in the isolation. The equipment preparation activity for the expanded isolation was scheduled for Sunday, November 29, 2015. In the alkylation unit weekend instructions, the unit superintendent noted the leaking isolation valve and directed operators to take the caustic settler out of service on Sunday to isolate the piping that was scheduled for replacement on Monday, November 30. In addition to the caustic settler, the expanded isolation plan required removing the contents of the coalescer to ensure the line to be replaced was free of hydrocarbons (Figure 4). An operator looked for a procedure or job aid for the task of taking those vessels out of service; however, no job aid or procedure existed, so the dayshift operator and board operator developed informal instructions for isolating and de-inventorying that equipment.

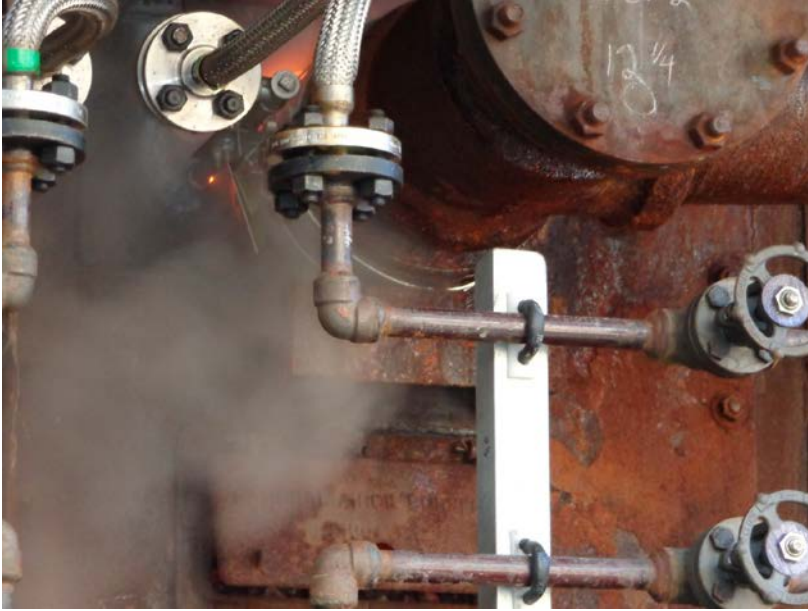
FIGURE 7. Burner on furnace (Source: CSB).

¹⁰ The investigation team concluded that the furnace, operating on an adjacent process unit downwind of the maintenance preparation activity, was the most likely source of ignition. The injured operator recalled the fire advancing toward him from the direction of the furnace. Isobutane vapors are known to travel to the source of ignition and flash back. The atmospheric conditions on the day of the incident would have allowed for the isobutane vapors to travel in the direction of the furnace.

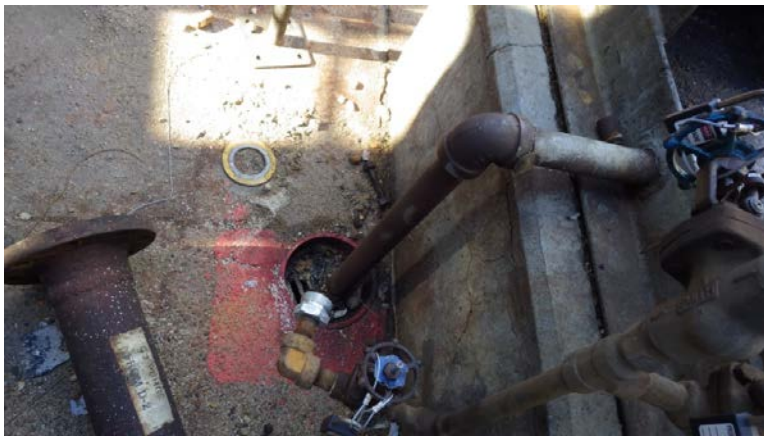
FIGURE 8. Typical pump drain to OWS (Source: CSB).
