Report Title: AB Specialty Silicones Explosion Assessment

Incident: May 3, 2019

Final Report Revision 1

ABS Group Project No. 4282052

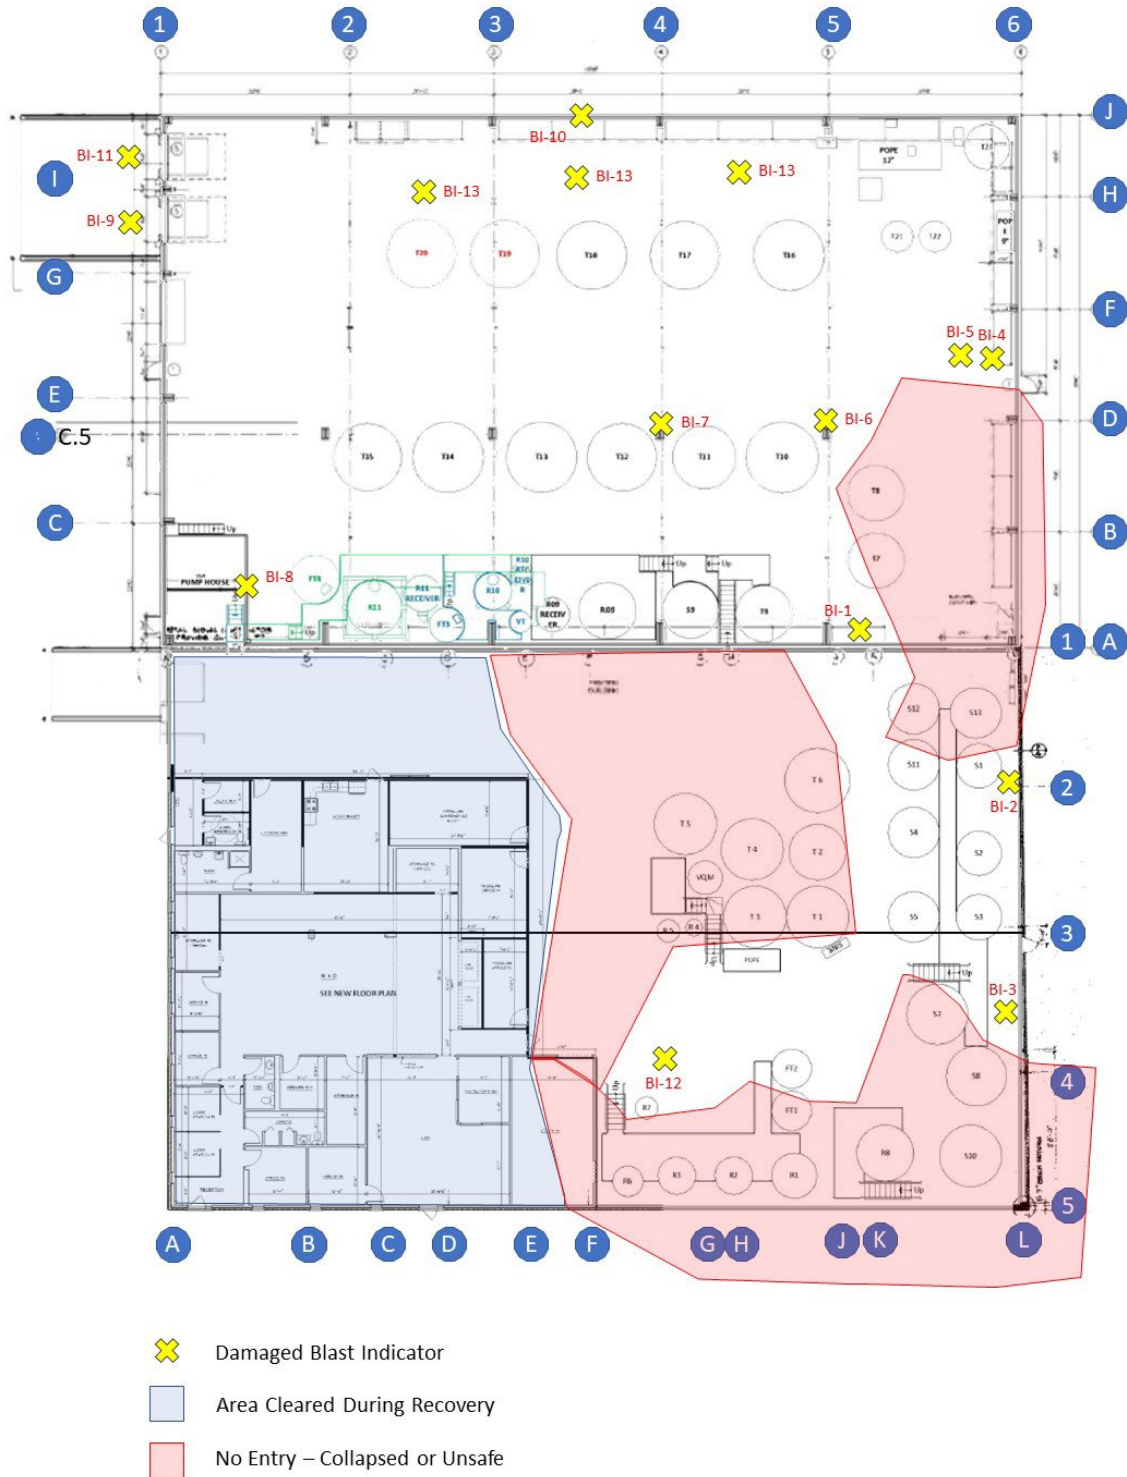
Figure 3-6. AB Specialty On-site Damaged Blast Indicators

ABS Consulting surveyed a number of blast indicators inside the Low Bay and High Bay areas of the AB Specialty facility. Reliable blast indicators are not severely damaged by the explosion and had consistent boundary conditions and loaded area. There were a handful of reliable damaged blast indicators such as electrical cabinet doors, electrical boxes, job boxes, and various structural members of the High Bay building. Damaged blast indicators in the survey are summarized below in Figure 3-6 and identified in Table 3-2 below. Examples of indicators provided in Figure 3-7 indicate that an explosion in the process area was severe enough to cause complete structural failure of the Low Bay as well as significant damage in the High Bay.

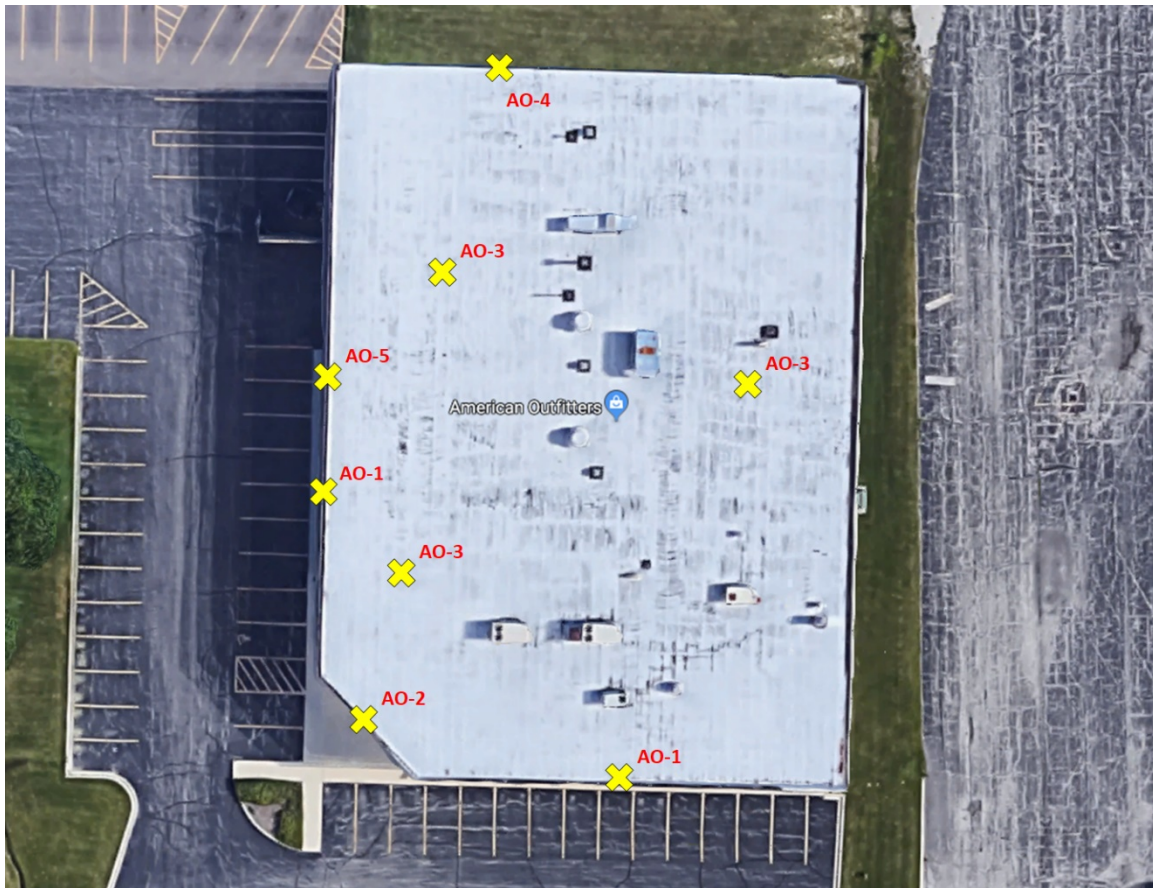
Figure 3-9. American Outfitters Blast Indicators

The three off-site locations closest to the AB Specialty facility provided the most suitable far-field blast indicators and included American Outfitters, Eagle Foods, and Woodland foods. At the American Outfitters building, there were broken and unbroken windows along with slightly damaged and undamaged roof joists. Examples of these off-site blast indicators are shown in Figure 3-9.

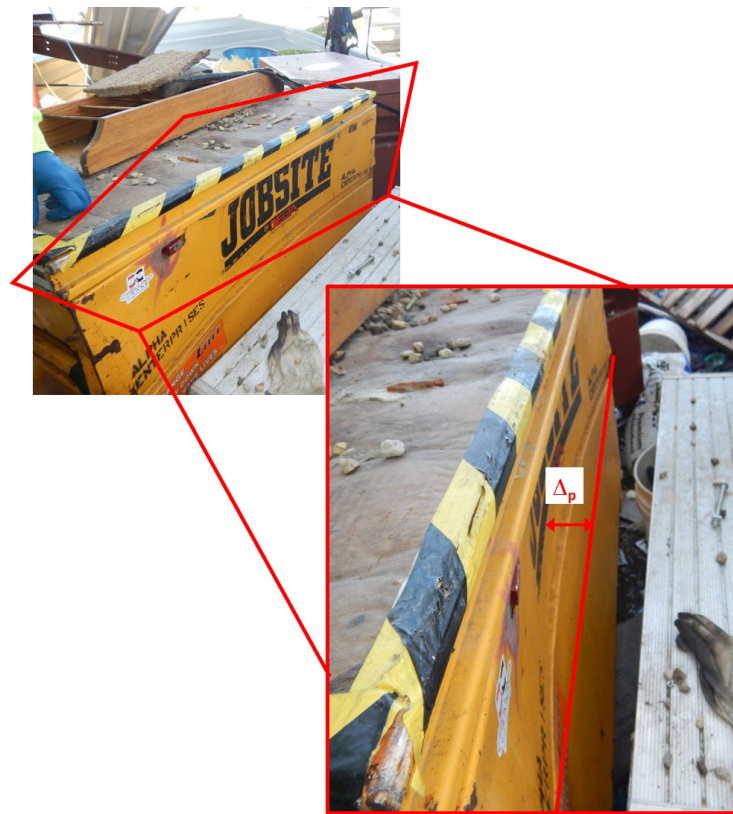
Figure 4-3. Measuring of Damaged Load Indicators

Damaged blast indicators were measured, as shown below in Figure 4-3, to determine the permanent deformation. The P-i diagram is developed for the peak response of the component, which differs from the permanent deformation due to elastic recovery after blast load dissipates, as shown in Figure 4-2.

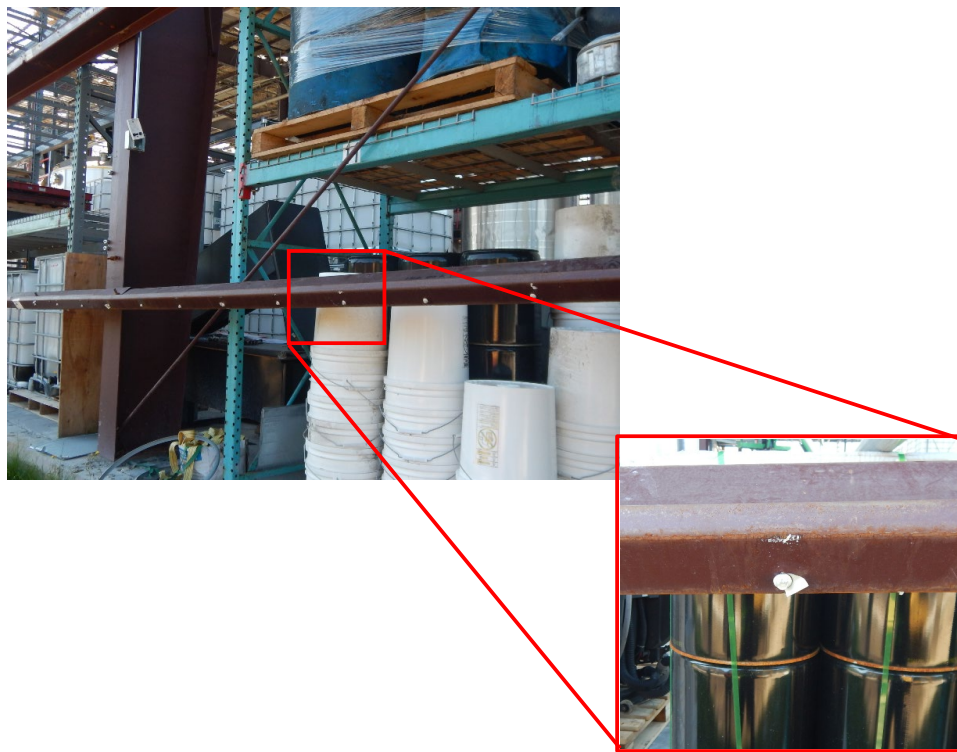
Figure 4-4. High Bay Metal Panel Connec

A qualitative blast damage assessment was performed for the High bay and Low Bay wall panels by comparing fastener's connection capacity (as determined by AISI 2001 Specification Section E4, Screws⁷) to blast pressures applied to the interior of the panels. It was observed on the site inspection that a majority of the wall panels of the High Bay were torn off and fasteners remained attached to the structural girts as shown in Figure 4-4. A similar condition was also observed on the insulated metal panels walls on the east elevation of the Low Bay. Fasteners that attached the structural girts to the panels were also found remaining on these girts. For these cases, by determining the tear out capacity of panel over the connection, a minimum threshold of the pressure applied to the internal surface of the wall panels was established.

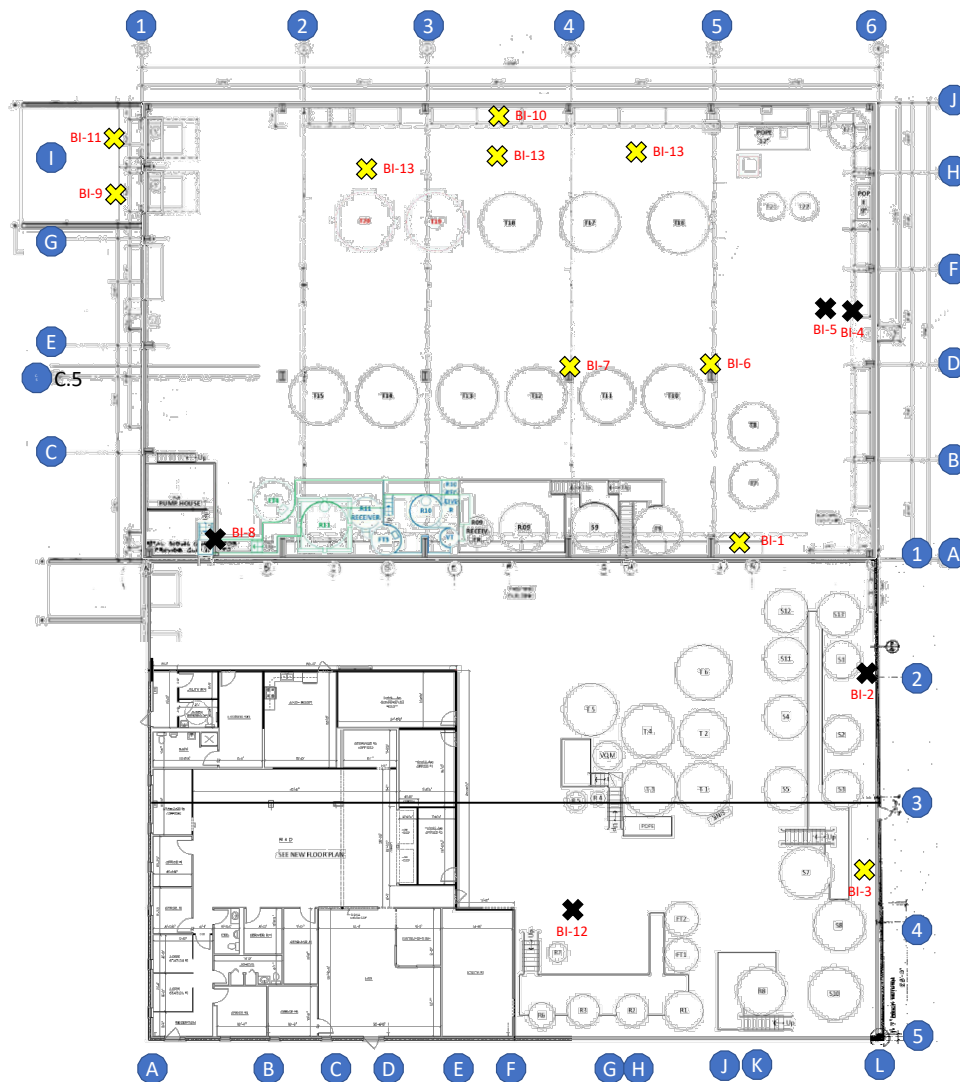
Figure 5-11. On-Site Blast Indicators – Black Evaluated

Explosion scenarios were evaluated by determining which blast indicators were consistent with the explosion modeling results. Figure 5-11 shows on-site blast indicators that were evaluated. The blast indicators denoted by a black “X” were included in the CFD model as targets and applied pressures and impulses were predicted. Indicators with a yellow “X” were measured but were not included in the CFD model and evaluations. Blast indicators marked by the yellow “X” were also observed and measured. However, structural analysis of the indicator did not produce practical results which was due to various factors including but not limited to varying loaded area, varying boundary conditions, multiple modes of response or failure, excessive damage, or large disparity between capacity of the indicator and overpressure.

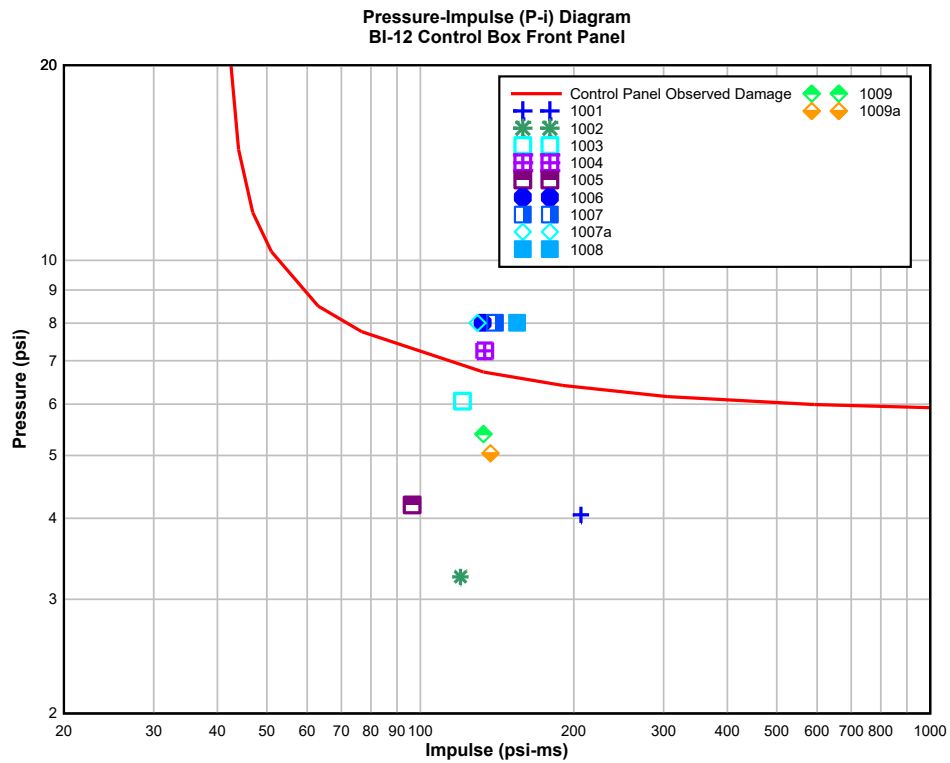
Figure 5-13. Blast Indicator BI-12 North Face P-i Diagrams and CFD Applied Loads

Blast indicator BI-12 was an electrical control box in the southwest region of the process area, shown in Figure 5-12. The P-i diagram was created for the control box north face and plotted along with the CFD blast loads in Figure 5-13. The P-i diagram falls between Scenarios 1001, 1002, 1003, 1005, and 1009 (&1009a) plotting below the curve. Scenarios 1004, 1006, 1007(&1007a), and 1008 plotting above the line. Scenario 1004 is essentially closest to the P-i curve as measured in log space. However, the control box was supported by two square tubing vertical struts cantilevered from the floor. The struts would also have bent away from the blast absorbing energy and reducing additional blast to create the damage to the front control panel. This resulted in consistency with Scenarios 1006, 1007, and 1008 for this specific comparison.

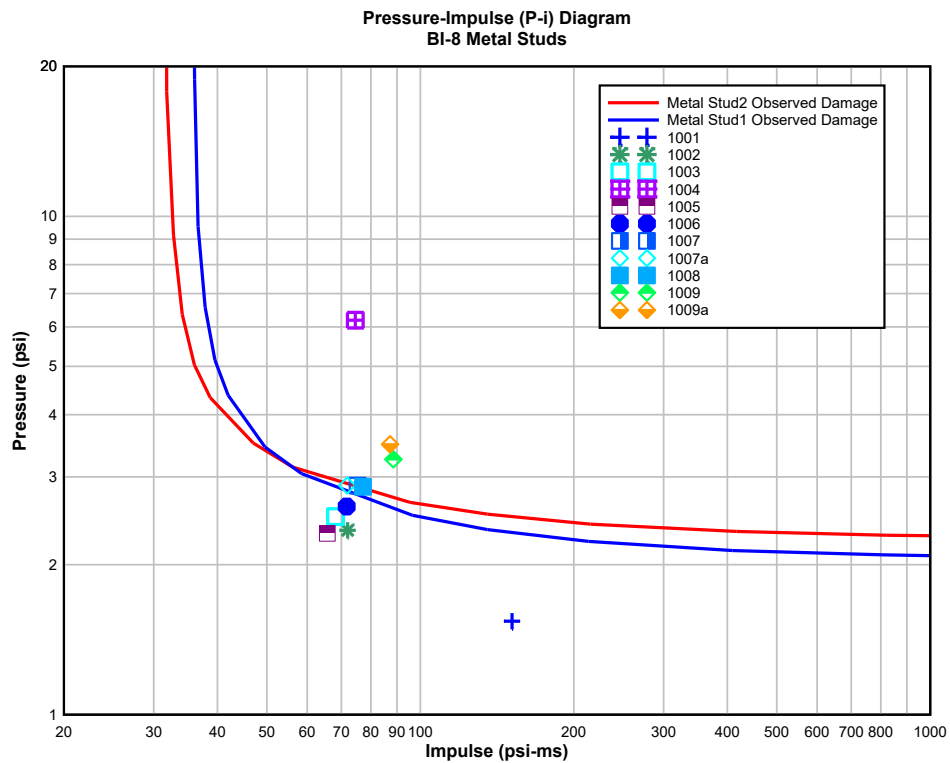
Figure 5-15. Blast Indicator BI-8 East Face P-i Diagrams and CFD Applied Loads

Blast indicator BI-8 was metal wall studs located on the southwest corner of the High Bay adjacent to the connection to the Low Bay. The metal stud wall is shown in Figure 5-14. This blast indicator is unique in that the two P-i diagrams were generated for the observed damage (two different studs with slightly different damage) could be plotted on the same chart and compared to the same applied blast loads, due to the close proximity of their location and orientation within the High Bay. The intersection of the two P-i diagrams, shown below in Figure 5-15, indicated the theoretical blast pressure and impulse at the location of blast indicator BI-8. It is noted that Scenarios 1007(&1007a) and 1008 are the most proximate to the two curves with Scenario 1006 just below.

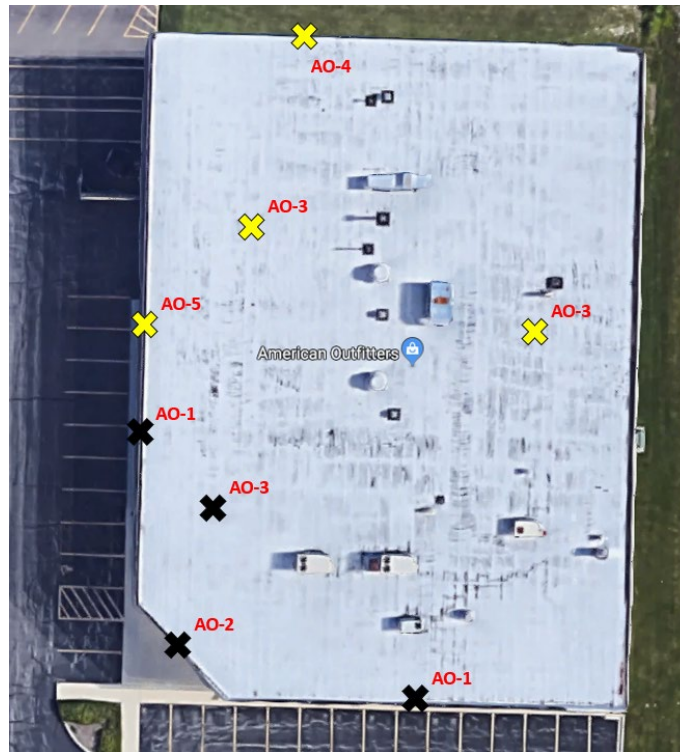
Figure 5-16. Off-Site Blast Indicators at American Outfitters– Black Evaluated

Similarly, off-site blast indicators at the American Outfitters, Eagle Foods, and Woodland Foods buildings were assessed. Off-site indicators that were evaluated are shown in Figure 5-16, Figure 5-17, and Figure 5-18. Select examples are discussed in the following paragraphs and evaluated blast indicator P-i diagrams are provided in Appendix B.

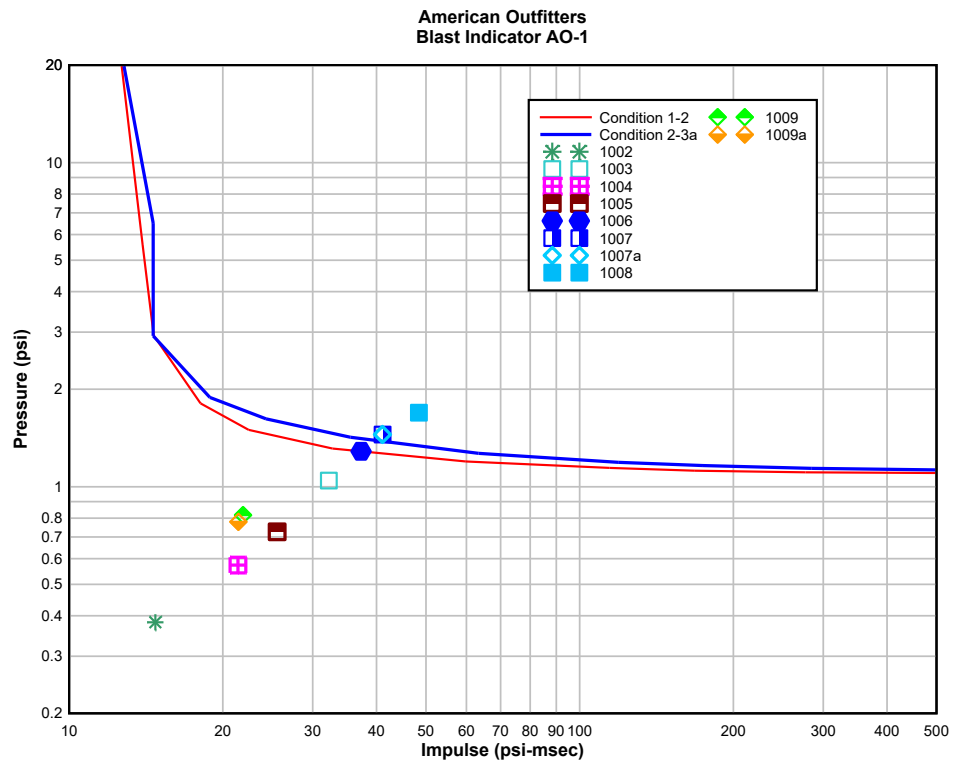
Figure 5-20. Blast Indicator AO-1 West Face P-i Diagrams and CFD Applied Loads

Off-site blast indicator AO-1 was a set of windows on the west face of the American Outfitters building as shown in Figure 5-19. Glazing in the windows was an insulated glass unit (IGU). All the windows on this face of the building were broken. Most of the broken glass was reported to be lying on the ground outside of the building after the explosion. This indicates that the blast wave was strong enough to break the windows but not energetic enough to accelerate and propel the glass into the building. Two P-i diagrams were developed for the typical window in the west elevation of the building. The first set of P-i data represent the threshold for breakage (Condition 1-2) of the window glazing and the second represents threshold for glass debris beyond 1 meter (Condition 2-3a) into the building. The P-i diagrams and explosion scenario blast loads at this location are shown in Figure 5-20. Only Scenarios 1006, 1007(&1007a), and 1008 showed pressure and impulses over the window breakage threshold. The higher blast loads of Scenario 1008 would indicate that the glass would have been propelled more into the building than was observed. Thus, Scenarios 1006 and 1007(&1007a) are most consistent with the window damage observed at this location.

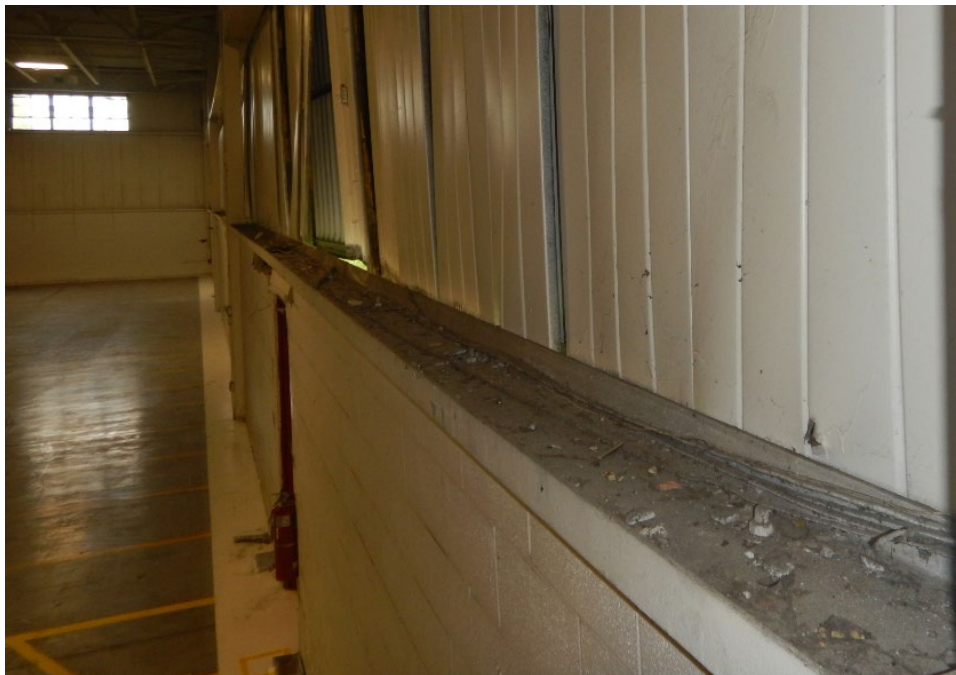
Figure 5-22. Blast Indicator EF-2

Off-site blast indicator EF-1 was an unreinforced concrete masonry unit (cmu) wall with brick veneer on the lower portion of the east elevation of the Eagle Foods building, shown in Figure 5-21. Eagle Foods is located to the west across Northwestern Avenue from the AB Specialty facility. Blast indicator EF-2 was a hot rolled steel girt supporting the top of the cmu wall at about 8 ft above the floor slab and supporting the metal wall panels above shown in Figure 5-22. Two sets of P-i data were developed for the cmu walls; the threshold of damage and observed damaged curves. The steel girt did not show signs of permanent damage, so, a threshold for damage curve was used for comparison with CFD applied loads. Figure 5-23 shows the P-i diagrams and CFD applied loads for the cmu walls and steel girt. Scenario 1001 blast loads are close to the cmu wall damage threshold curve. Scenarios 1002, 1004, 1005, 1009(&1009a) loads exceed the observed cmu damage curve and not consistent with the damage. Scenarios 1006, 1007(&1007a), and 1008 are the most consistent with undamaged cmu blast indicator. All the scenarios are below the threshold of damage for the steel girt which is consistent with lack of permanent damage to the member.
